BSWWRRG Resource Recovery Centre Assessment

Balmoral
Site Assessment Report

RESOURCE RECOVERY CENTRE ASSESSMENTS

Site Name Balmoral Resource Recovery Centre

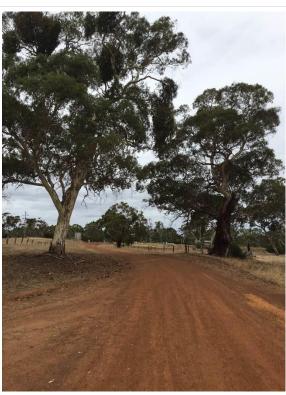
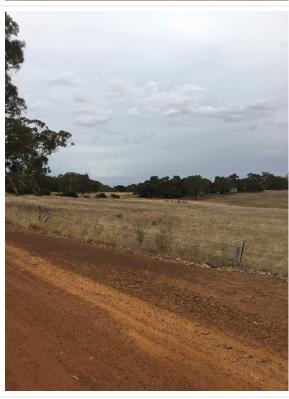
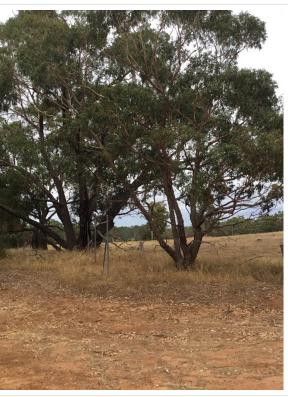
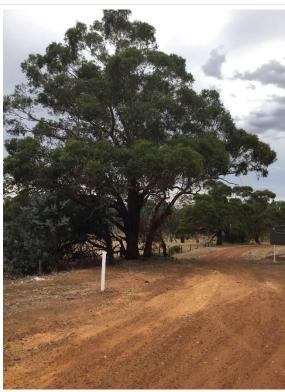
Take photos of the siting and screening

None. The site is very large with significant space to accommodate additional infrastructure.

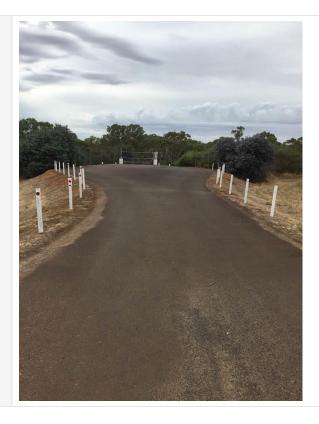
Take a photo of fencing issues

Upgrades required to site fencing and security	The site is not secure with low level farm fencing and a farm gate.
Upgrades required to covered areas / sheds for recycling	The site lacks covered areas and/or shedding for the collection and storage of batteries, gas bottles and mattresses.
Upgrades required for complaint collection and storage of e-waste	E-waste is stored in a manner which is not compliant with AS5377. If the site is to continue accepting e-waste after 1 July 2019, new infrastructure will be required, such as a secure shed with bunded hardstand.
Upgrades required to hazardous materials / dangerous goods storage	Batteries should be stored in a secured shed with bunded hardstand. Gas bottles should be stored away from direct sunlight. The oil disposal unit requires bunding to the hardstand.
Improvements to site layout and traffic flow	In the medium to long term the site would benefit from an improved layout that encouraged recycling cling and allowed for improved oversight over the green waste drop off area.

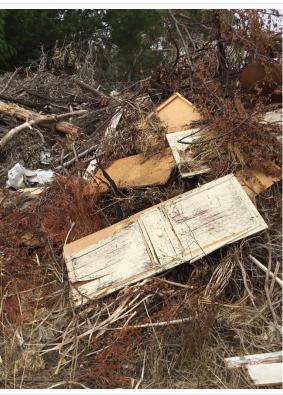
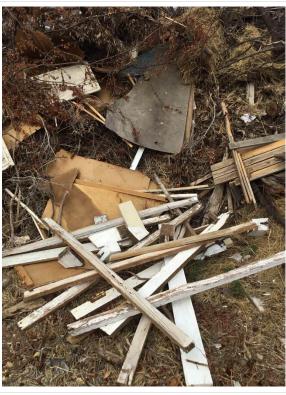
Take photos of storage of this material

Does the site accept timber waste?	Yes
How is the material stored?	Loose in pile
Is it stored in a covered or uncovered area / bin?	Uncovered area
Size of the bin or storage area	Large open area (e.g. metals or green waste area)
What surface is it (or its skip bin) stored on?	No hardstand (on dirt)

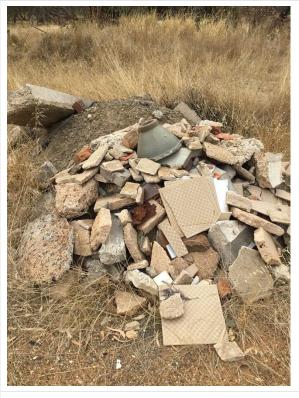
Take photos of storage of this material

Does the site accept brick / rock / rubble?	Yes
How is the material stored?	Loose in pile
Is it stored in a covered or uncovered area / bin?	Uncovered area
Size of the bin or storage area	Large open area (e.g. metals or green waste area)
What surface is it (or its skip bin) stored on?	No hardstand (on dirt)

Crushed and used by council

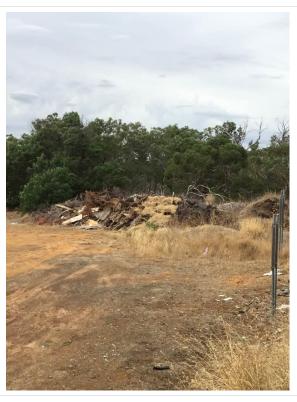
Take a photo of the green waste area

Is the green waste drop-off area visible from the gatehouse?	No
Provide details	Rear of site
Does water drain from the green waste area (visually or reportedly, look for pools of water)?	Yes
Is storm water runoff and leachate actively managed from the green waste area?	No
Provide details of storm water and leachate management	Natural drainage

Improvements to oversight of incoming loads	Oversight on green waste disposal could be improved which would reduce contamination and improve the quality of material for processing.
Improvements to garden organics management practices	Green waste is currently stored and processed with timber, including some manufactured timber. This practice limits the quality and saleability of end products. Timber and green waste should be separated and processed separately, and improved oversight over this area of the site could reduce contamination and further improve conditions. There are legacy piles of processed material at the site that speak to the quality issues. These legacy piles should also be addressed in the short to medium term.

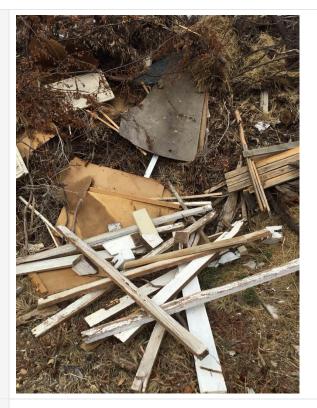
Does the site accept green waste?	Yes
How is the material stored?	Loose in pile
Is it stored in a covered or uncovered area / bin?	Uncovered area
Size of the bin or storage area	Large open area (e.g. metals or green waste area)
What surface is it (or its skip bin) stored on?	No hardstand (on dirt)
Take photos of storage of this material

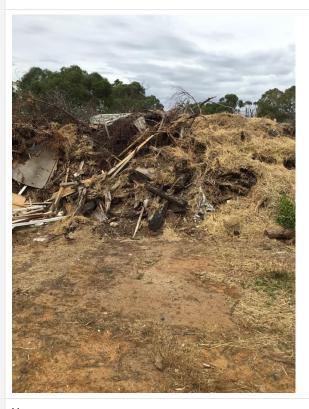
Take a photo of the unprocessed green waste stockpile

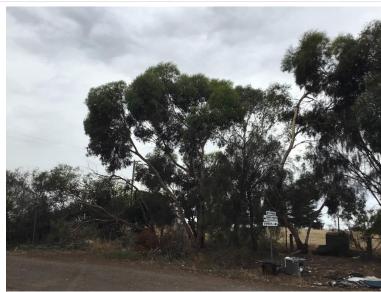
General comments on siting	The site is located about 1km outside of the township in a farming and rural area. The nearest house is less than 100m away across the road from the front gate. It is a small facility on a small parcel of land adjacent the council depot.
Site constraints / limitations / concerns	The size of the site would restrict large scale development, however there is scope for construction of covered areas and additional infrastructure. It is unclear whether the site is located on a closed landfill.
Take photos of the siting and screening

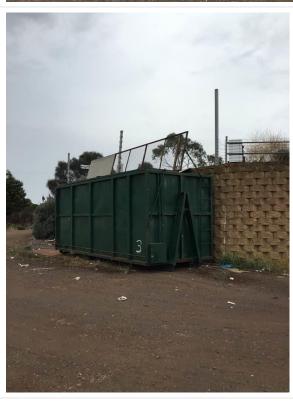
Infrastructure on site (select all)	Gatehouse, Engineered retaining walls, Skip bins (uncovered), Concrete pad(s)
Utilities on site (select all)	Water (tank)
General comments on site infrastructure	This is a poorly developed site that lacks any genuine infrastructure to support resource recovery.
Take photos of key site infrastructure	GILLAND D VIRILAND D V

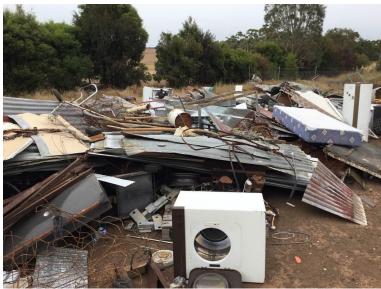
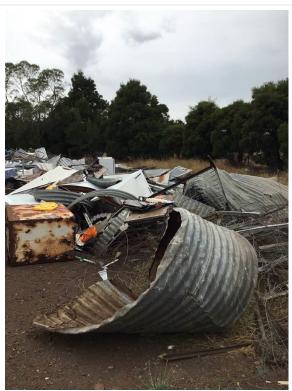
Take photos of storage of this material

Does the site accept metals?	Yes
How is the material stored?	Loose in pile
Is it stored in a covered or uncovered area / bin?	Uncovered area
Size of the bin or storage area	Large open area (e.g. metals or green waste area)
What surface is it (or its skip bin) stored on?	No hardstand (on dirt)

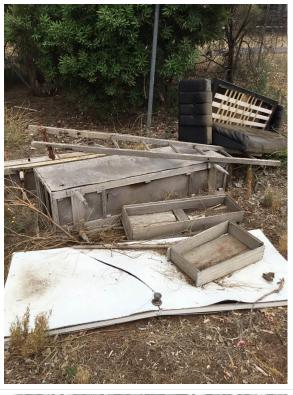
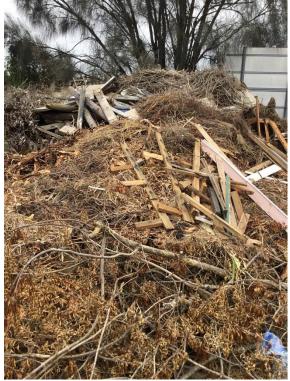
Is it stored in a covered or uncovered area / bin?	Uncovered area
Size of the bin or storage area	Large open area (e.g. metals or green waste area)
What surface is it (or its skip bin) stored on?	No hardstand (on dirt)
Take photos of storage of this material

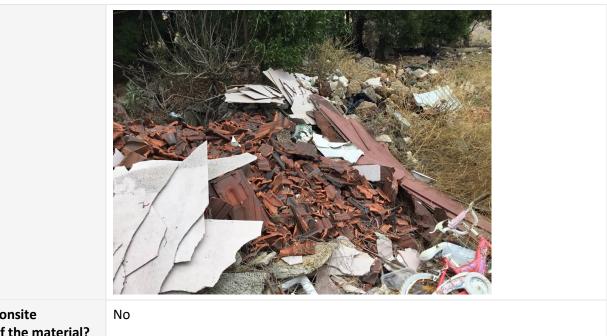
Does the site accept brick / rock / rubble?	Yes
How is the material stored?	Loose in pile
Is it stored in a covered or uncovered area / bin?	Uncovered area
Size of the bin or storage area	Large open area (e.g. metals or green waste area)
What surface is it (or its skip bin) stored on?	No hardstand (on dirt)
Take photos of storage of this material

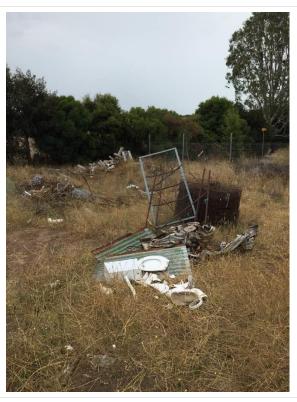
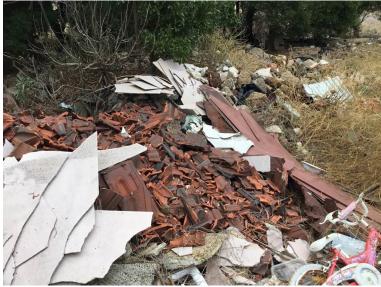
Take photos of storage of this material

Does the site accept concrete?	Yes
How is the material stored?	Loose in pile
Is it stored in a covered or uncovered area / bin?	Uncovered area
Size of the bin or storage area	Large open area (e.g. metals or green waste area)
What surface is it (or its skip bin) stored on?	No hardstand (on dirt)

A number of piles of building rubble exist which are mixed with general building products including asbestos.

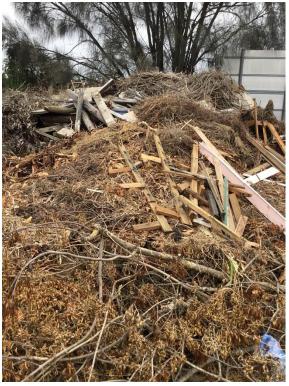
Does the site accept green waste?	Yes
How is the material stored?	Loose in pile
Is it stored in a covered or uncovered area / bin?	Uncovered area
Size of the bin or storage area	Large open area (e.g. metals or green waste area)
What surface is it (or its skip bin) stored on?	No hardstand (on dirt)
Take photos of storage of this material

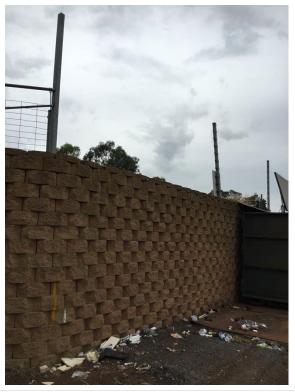
Are there any obvious risks at the site?	Yes
Detail obvious site risks	Asbestos contamination and falls risk evident from the general waste platform
Are all loads supervised upon entry to the site?	Yes - inspected from an elevated gatehouse
Is the traffic flow unidirectional and free from cross-roads?	Yes - traffic management is good
Is there suitable signage that directs site users around the site and to different materials areas?	No - signage requires improvement
Detail site signage improvements required	Signage needs upgrades throughout the facility.
Are there manual handling risks on site?	No
Take photos of each risk

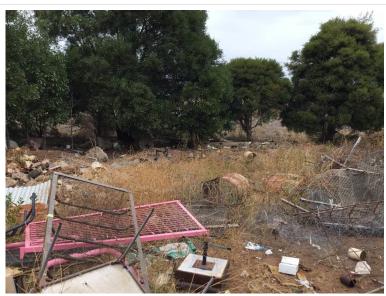
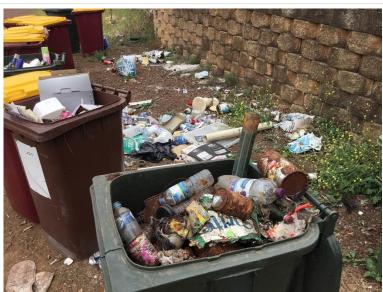
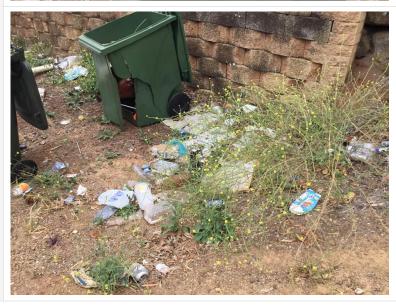
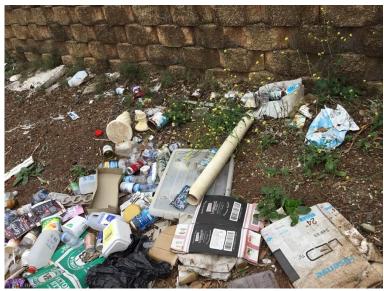
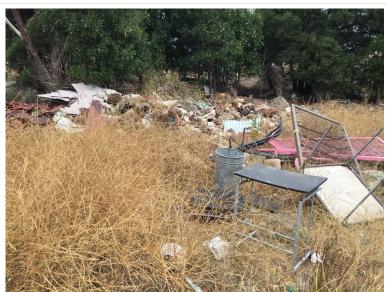
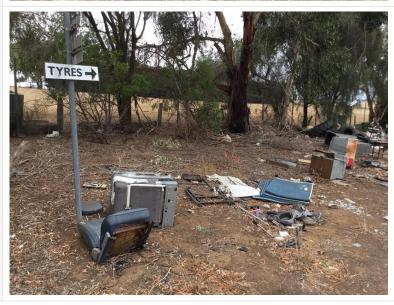
Take photos of relevant environmental management issues

Describe general site amenity	Messy and poorly kept
Provide details	This site is impacted by extensive littering and debris in all areas of the site. It is poorly managed and a significant issue from a visual amenity perspective. Piles of material are across the site, mostly mixed material which have now been grown over by vegetation. Immediate attention is required to improve the conditions of this facility and to make it safe for customers.
Is windblown litter visible outside the site or is there a history of litter issues?	Yes
Is windblown litter or general debris visible within the site itself?	Yes
Provide details	Throughout entire site
Are there issues with dust at the site, particularly in drier months?	Yes
Are there issues with odour at the site or have there been odour complaints?	No
Are there issues with noise at the site or have there been noise complaints?	No
General comments about environmental management at the site	This site is poorly managed and is in a condition that poses a risk to human health and the environment.

Improvements to site amenity / tidiness	The site is extremely untidy and suffers from litter and debris across almost the entire facility. The level of contamination and debris has significantly impacted visual amenity and is likely to be contributing to further poor practice at the site. A full site clean up is required, and it recommended as part of this that suitably qualified asbestos practitioners are engaged to examine likely asbestos debris and remove this material under controlled conditions.
Improvements to oversight of incoming loads	The level of contamination that is evident in material piles such as green waste and building rubble, and the general conditions at the site suggest that a full overhaul of load inspection processes is required. This should include further operator

training, increased signage throughout the site and installation of CCTV cameras to capture the rear of the site where much of the dumping is occurring.
Improvements to overall management practices	As detailed above, site practices need to be significantly improved, including load oversight, directions for customers and management of litter and debris at the site. It was reported that a new operator has been engaged and is actively looking for areas to improve.
Improvements to management of hazardous materials / dangerous goods	As noted previously, it is unclear how and where batteries and gas bottles are stored. If the site does accept them then new infrastructure is required, if not then clearer signage is required.
Improvements to garden organics management practices	Garden organics are stored with timber and the current stockpile is heavily contaminated with plastics and other materials. Mulching occurs at long intervals and the product quality is likely to be very poor with material used on the site. Timber and green waste should be collected, stored and processed separately to reduce contamination and improve overall product quality.

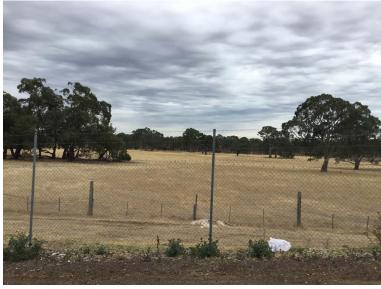
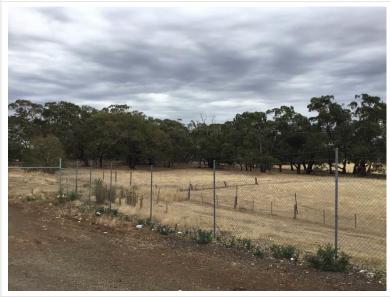
Prior land-use	Landfill (RRC is built adjacent to old fill area)
General comments on siting	The site is located on a large, relatively flat rural block with good buffers and limited chance of encroachment.
Site constraints / limitations / concerns	None. Site has good scope for further development.
Take photos of the siting and screening	2-3-2

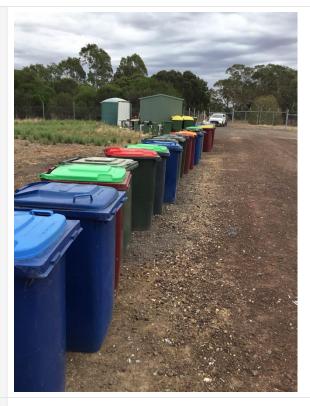
How is the material stored?	Skip bin
Is it stored in a covered or uncovered area / bin?	Uncovered area
Size of the bin or storage area	Small stillage or skip bin (<5m3)
What surface is it (or its skip bin) stored on?	No hardstand (on dirt)
Take photos of storage of this material

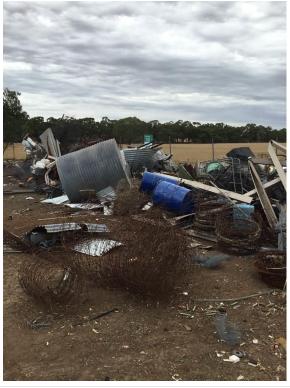
Does the site accept metals?	Yes
How is the material stored?	Loose in pile
Is it stored in a covered or uncovered area / bin?	Uncovered area
Size of the bin or storage area	Large open area (e.g. metals or green waste area)
What surface is it (or its skip bin) stored on?	No hardstand (on dirt)
Take photos of storage of this material

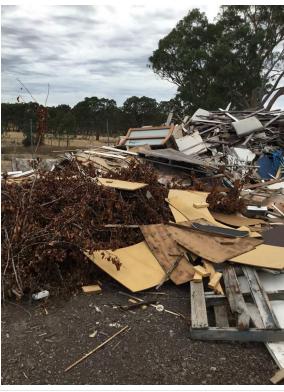
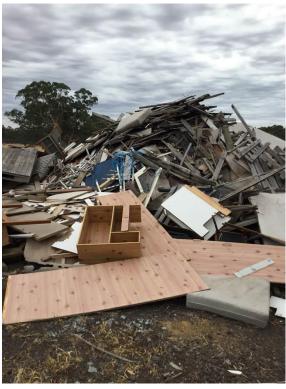
Take photos of storage of this material

Does the site accept timber waste?	Yes
How is the material stored?	Loose in pile
Is it stored in a covered or uncovered area / bin?	Uncovered area
Size of the bin or storage area	Large open area (e.g. metals or green waste area)
What surface is it (or its skip bin) stored on?	No hardstand (on dirt)

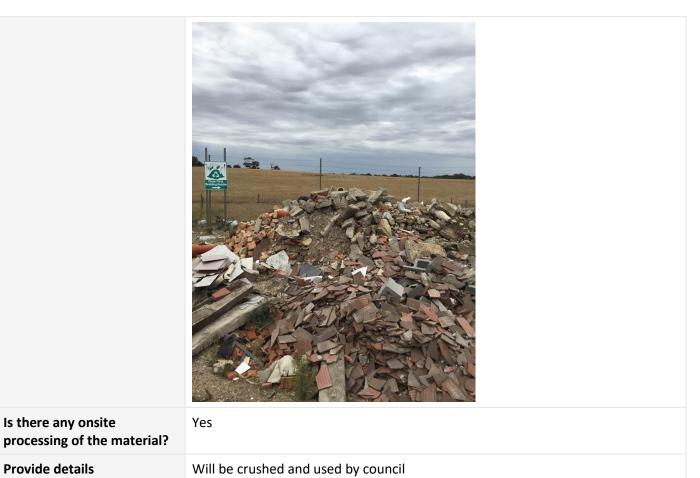
Does the site accept brick / rock / rubble?	Yes
How is the material stored?	Loose in pile
Is it stored in a covered or uncovered area / bin?	Uncovered area
Size of the bin or storage area	Large open area (e.g. metals or green waste area)
What surface is it (or its skip bin) stored on?	No hardstand (on dirt)
Take photos of storage of this material

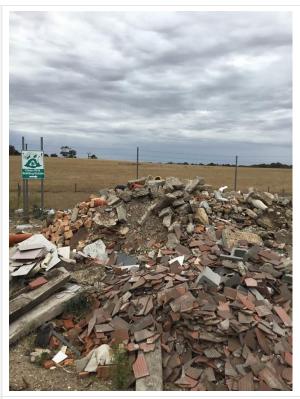
Take photos of storage of this material

Does the site accept concrete?	Yes
How is the material stored?	Loose in pile
Is it stored in a covered or uncovered area / bin?	Uncovered area
Size of the bin or storage area	Large open area (e.g. metals or green waste area)
What surface is it (or its skip bin) stored on?	No hardstand (on dirt)

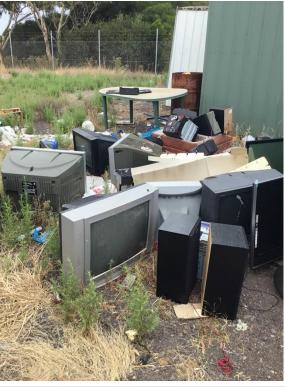
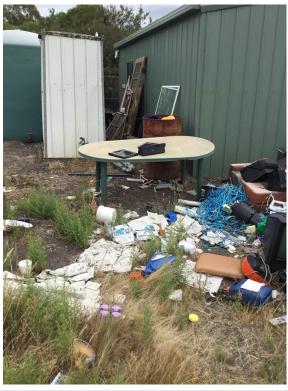
Take photos of storage of this material

Does the site accept e-waste?	Yes
How is the material stored?	Loose in pile
Is it stored in a covered or uncovered area / bin?	Uncovered area
Size of the bin or storage area	Large open area (e.g. metals or green waste area)
What surface is it (or its skip bin) stored on?	No hardstand (on dirt)

Complaint e-waste collection and storage area	E-waste is stored in a manner which is not compliant with AS5377. If the site is to continue accepting e-waste after 1 July 2019, new infrastructure will be required such as a secure shed with hardstand.
Hazardous materials / dangerous goods storage	New infrastructure for storage of batteries and gas bottles is required, such as covered areas and/or shedding with a bunded hardstand.
Paved roads and hardstand areas	The site lacks paved roads and hardstands throughout. Upgrades should be considered as part of upgrades to the site.
MANAGEMENT PRACTICES	COMMENTS / CHANGES REQUIRED
Improvements to site amenity / tidiness	The site suffers from extensive littering and debris across the site. A full clean up is required to improve visual amenity and reduce the risk of further poor practices.
Improvements to oversight of incoming loads	The likely presence of asbestos and extent of debris across the site suggests that oversight of loads requires significant improvement. This should include new signage, further operator training and potential installation of CCTV to the rear of the site where most of the dumping and debris occurs.

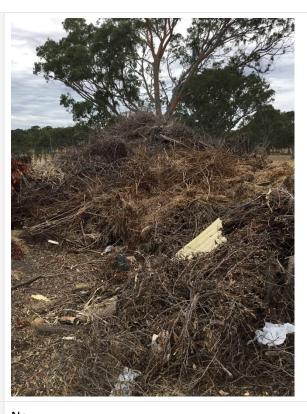
Take a photo of the green waste area

Is the green waste drop-off area visible from the gatehouse?	No
Provide details	At rear of site
Does water drain from the green waste area (visually or reportedly, look for pools of water)?	Yes
Is storm water runoff and leachate actively managed from the green waste area?	No
Provide details of storm water and leachate management	Natural drainage with some gullying
General comments about drop off area	Significant contamination evident

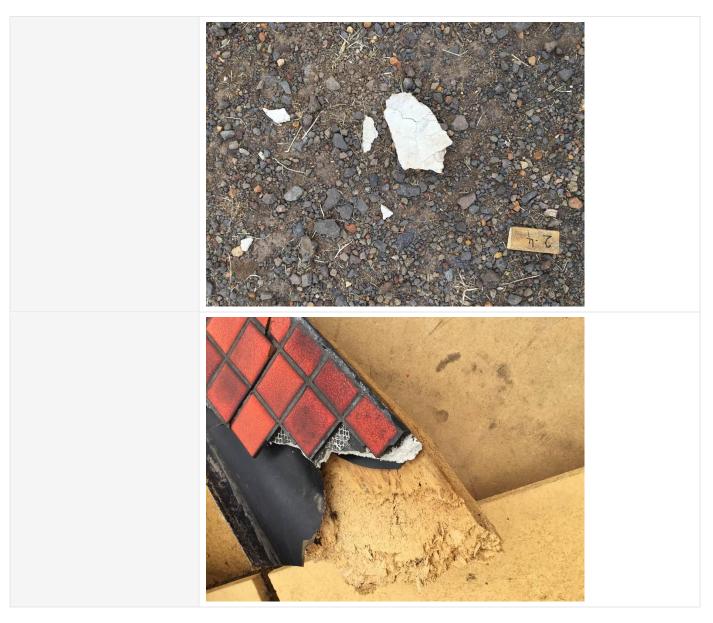
Are there any obvious risks at the site?	Yes
Detail obvious site risks	Asbestos present
Are all loads supervised upon entry to the site?	Yes - inspected from ground level gatehouse
Provide details of load inspection process	Inspection process need improvement as evidenced by contamination and asbestos waste
Is the traffic flow unidirectional and free from cross-roads?	Yes - traffic management is good
Is there suitable signage that directs site users around the site and to different materials areas?	Yes - signage is adequate
Are there manual handling risks on site?	No
Take photos of each risk

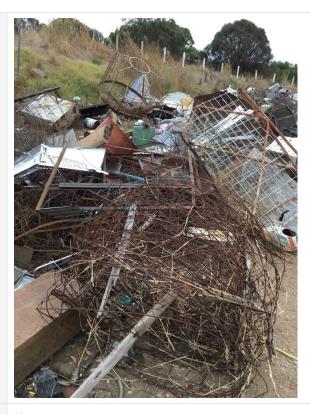
Does the site accept metals?	Yes
How is the material stored?	Loose in pile
Is it stored in a covered or uncovered area / bin?	Uncovered area
Size of the bin or storage area	Large open area (e.g. metals or green waste area)
What surface is it (or its skip bin) stored on?	No hardstand (on dirt)

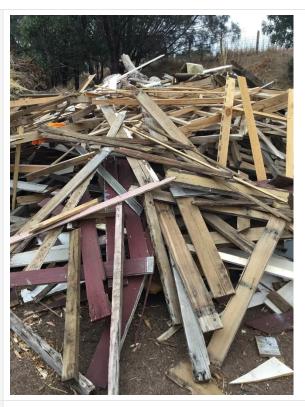
Does the site accept timber waste?	Yes
How is the material stored?	Loose in pile
Is it stored in a covered or uncovered area / bin?	Uncovered area
Size of the bin or storage area	Large open area (e.g. metals or green waste area)
What surface is it (or its skip bin) stored on?	No hardstand (on dirt)

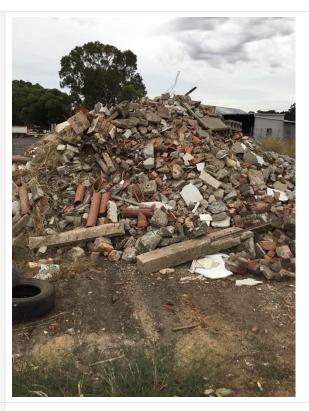
Does the site accept brick / rock / rubble?	Yes
How is the material stored?	Loose in pile
Is it stored in a covered or uncovered area / bin?	Uncovered area
Size of the bin or storage area	Large open area (e.g. metals or green waste area)
What surface is it (or its skip bin) stored on?	No hardstand (on dirt)

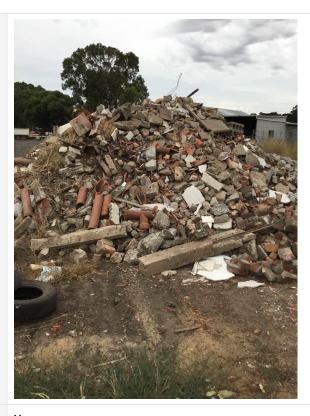
Does the site accept concrete?	Yes
How is the material stored?	Loose in pile
Is it stored in a covered or uncovered area / bin?	Uncovered area
Size of the bin or storage area	Large open area (e.g. metals or green waste area)
What surface is it (or its skip bin) stored on?	No hardstand (on dirt)

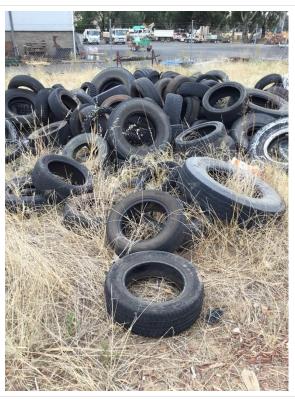
Does the site accept tyres?	Yes
How is the material stored?	Loose in pile
Is it stored in a covered or uncovered area / bin?	Uncovered area
Size of the bin or storage area	Large open area (e.g. metals or green waste area)
What surface is it (or its skip bin) stored on?	No hardstand (on dirt)

Is there any onsite processing of the material?	Yes
Provide details	In the past have been shredded onsite. Unsure what happens.

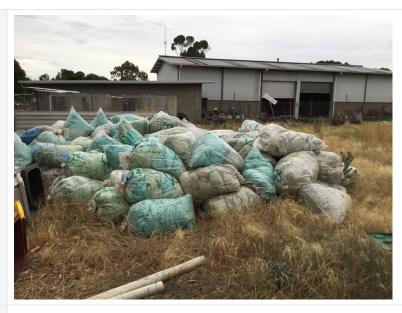
Does the site accept separated agricultural waste (silage wrap)?	Yes
How is the material stored?	Loose in pile
Is it stored in a covered or uncovered area / bin?	Uncovered area
Size of the bin or storage area	Large open area (e.g. metals or green waste area)
What surface is it (or its skip bin) stored on?	No hardstand (on dirt)

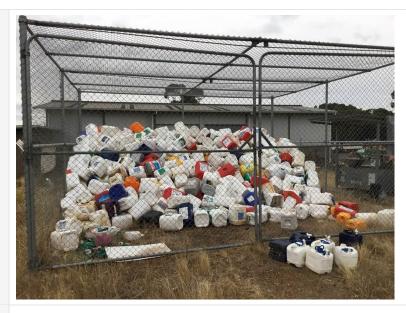
Does the site accept agricultural drums (DRUMuster)?	Yes
How is the material stored?	Loose in pile
Is it stored in a covered or uncovered area / bin?	Uncovered area
Size of the bin or storage area	Medium stillage or skip bin (5 - 20m3)
What surface is it (or its skip bin) stored on?	No hardstand (on dirt)

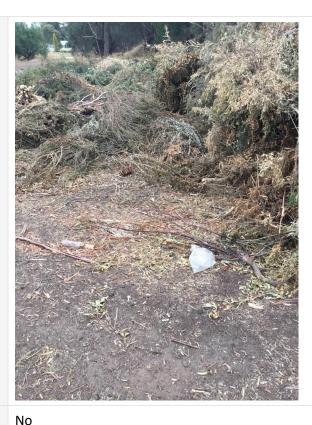
Take a photo of the green waste area

is the green waste drop-off	
area visible from the	
gatehouse?	
Provide details

NO

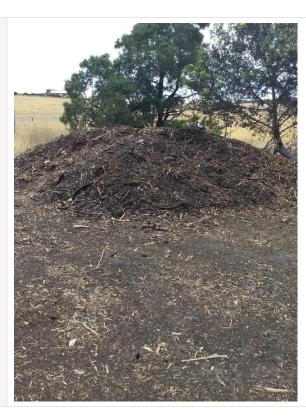
Take a photo of the processed (mulch) green waste stockpile

Is green waste processed onsite?	Yes
Provide details	Shredded as mulch and used as cover or given away

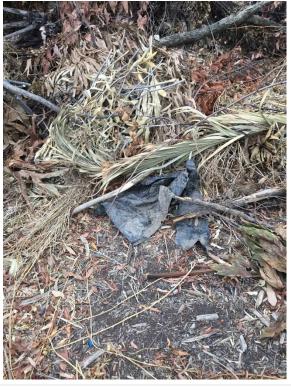
Take a close-up photo of visible contamination (if any can be seen)

Visual inspection at gatehouse

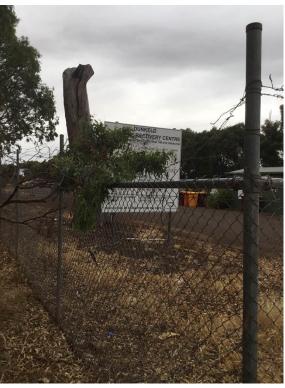
Take a photo of fencing issues

Does the site have CCTV?	No
Does the site suffer breakins and/or illegal dumping?	No

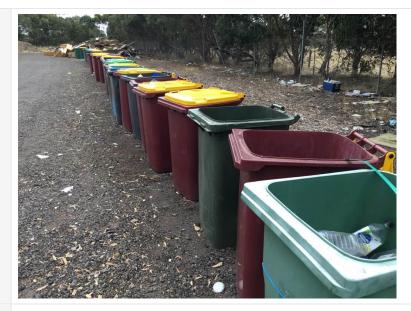
Does the site accept commingled recyclables?	Yes
How is the material stored?	Skip bin
Is it stored in a covered or uncovered area / bin?	Uncovered area
Size of the bin or storage area	Small stillage or skip bin (<5m3)
What surface is it (or its skip bin) stored on?	No hardstand (on dirt)

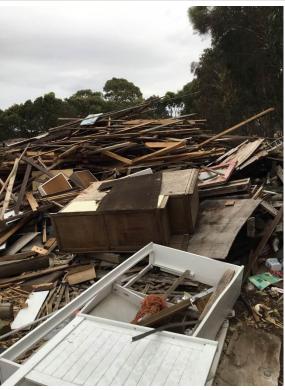
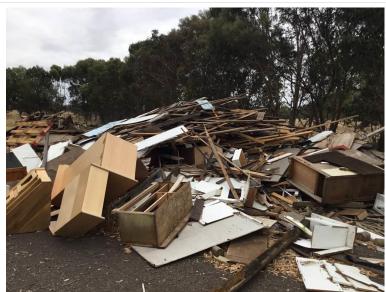
Does the site accept timber waste?	Yes
How is the material stored?	Loose in pile
Is it stored in a covered or uncovered area / bin?	Uncovered area
Size of the bin or storage area	Large open area (e.g. metals or green waste area)
What surface is it (or its skip bin) stored on?	No hardstand (on dirt)

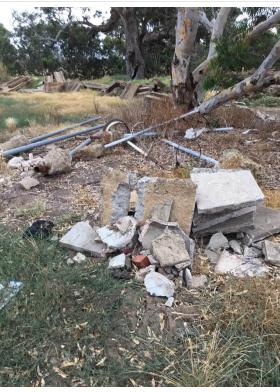
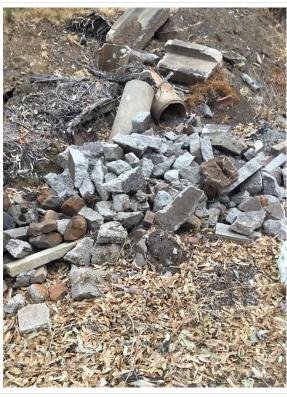
Does the site accept concrete?	Yes
How is the material stored?	Loose in pile
Is it stored in a covered or uncovered area / bin?	Uncovered area
Size of the bin or storage area	Large open area (e.g. metals or green waste area)
What surface is it (or its skip bin) stored on?	No hardstand (on dirt)

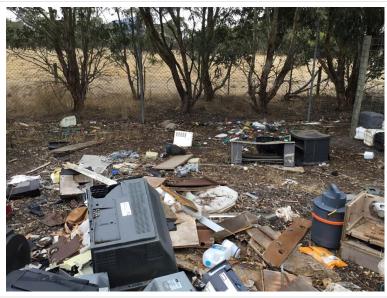
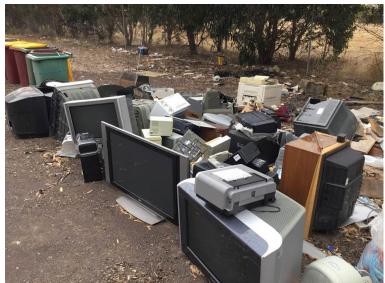
Does the site accept e-waste?	Yes
How is the material stored?	Loose in pile
Is it stored in a covered or uncovered area / bin?	Uncovered area
Size of the bin or storage area	Large open area (e.g. metals or green waste area)
What surface is it (or its skip bin) stored on?	No hardstand (on dirt)

Complaint e-waste collection and storage area	E-waste is stored in a manner which is not compliant with AS5377. If the site is to continue accepting e-waste after the 1 July 2019 new infrastructure will be required such as a secure shed with hardstand.
Hazardous materials / dangerous goods storage	Storage of batteries is currently a key issue at the site with damaged and leaking batteries stored in the open and on the ground. Construction of new storage infrastructure for batteries (as well as other key materials outlined previously) should be a term priority for the site.
Improvements to layout and traffic flow	The site has a number of access roads, many of which lack signage and directional linemarking. A near miss between a residential customer and a landfill truck was observed at the time of the site visit.
	Upgrades to signage and clear linemarking, such as colour coded lanes to separate customers from site vehicles is recommended. In addition, further driver education may be required as several site vehicles were observed travelling well in excess of walking pace.

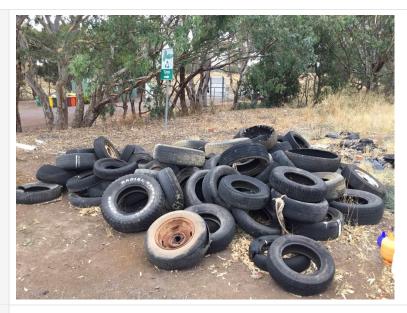
Does the site accept tyres?	Yes
How is the material stored?	Loose in pile
Is it stored in a covered or uncovered area / bin?	Uncovered area
Size of the bin or storage area	Large open area (e.g. metals or green waste area)
What surface is it (or its skip bin) stored on?	No hardstand (on dirt)

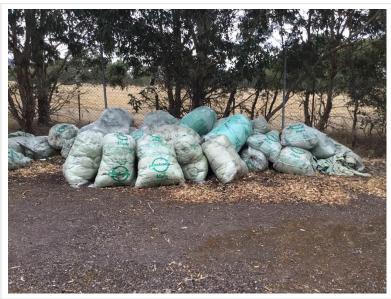
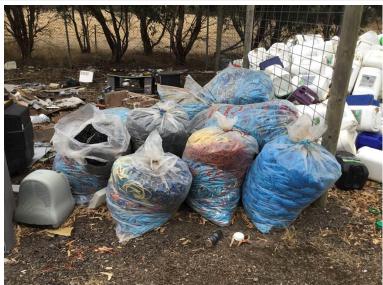
Does the site accept separated agricultural waste (silage wrap)?	Yes
How is the material stored?	Loose in pile
Is it stored in a covered or uncovered area / bin?	Uncovered area
Size of the bin or storage area	Large open area (e.g. metals or green waste area)
What surface is it (or its skip bin) stored on?	No hardstand (on dirt)

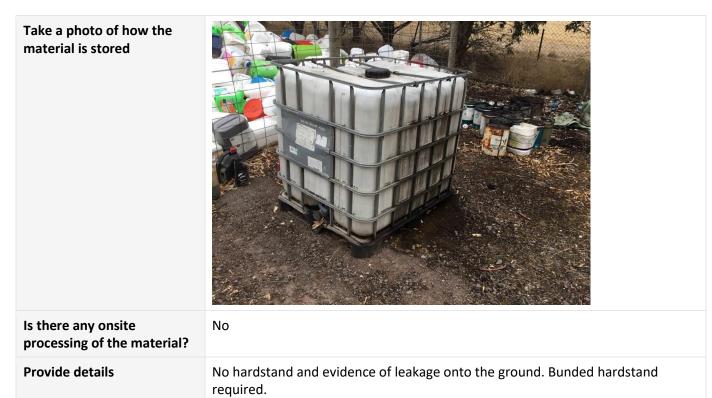
Does the site accept waste oil?	Yes
How is the material stored?	Drum
Is it stored in a covered or uncovered area / bin?	Uncovered area
Size of the bin or storage area	Small stillage or skip bin (<5m3)
What surface is it (or its skip bin) stored on?	No hardstand (on dirt)
Is the material stored in a manner that is required under the relevant regulations (e.g. bunding, fully enclosed, weatherproof etc.)?	No

Upgrades required to hazardous materials / dangerous goods storage	Storage of waste oil and used oil containers needs to be addressed as a priority, for example by construction of a bunded hardstand for the oil drum which will contain spills and leakage. Used bottles should be stored in a bin or stillage rather than loose on the ground. The collection and storage of batteries and gas bottles does not meet better practice guidelines. New infrastructure is required such as a secure shed with hardstand.
Improvements to roads and hardstand areas	Paved roads and hardstands should be considered in the long term as part of overall development of the site.

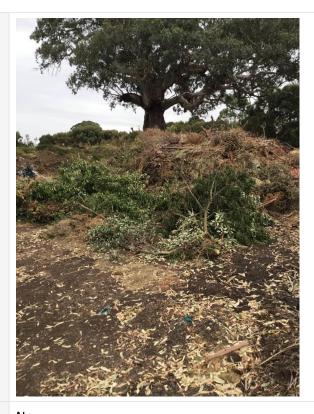
Take a photo of the green waste area

Does the site accept green waste?	Yes
How is the material stored?	Loose in pile
Is it stored in a covered or uncovered area / bin?	Uncovered area
Size of the bin or storage area	Large open area (e.g. metals or green waste area)
What surface is it (or its skip bin) stored on?	No hardstand (on dirt)
Take photos of storage of this material

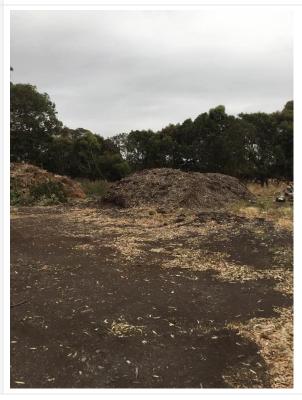
Take a photo of the processed (mulch) green waste stockpile

Used as required by council, appears to have been here for some time

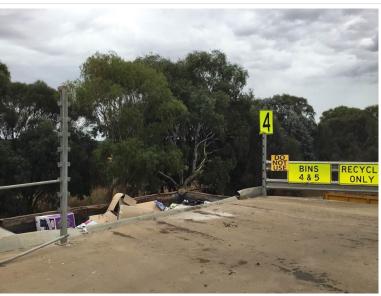
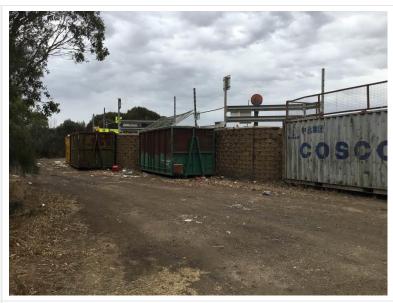
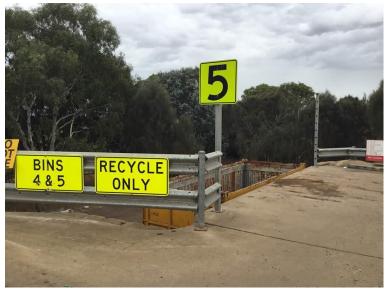
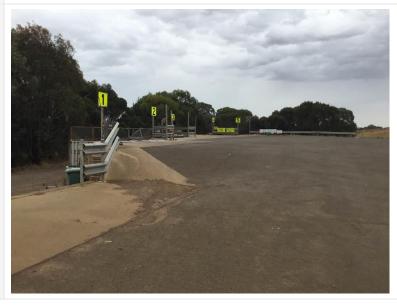
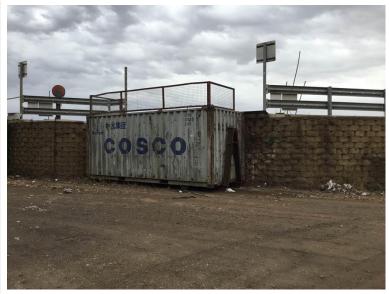
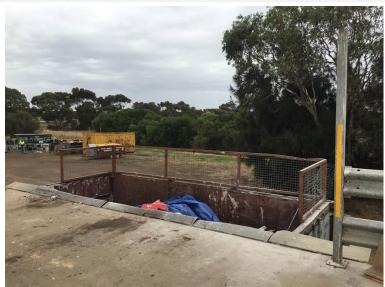
hardstand and skip bins

Describe the area for residual waste collection	Fully elevated platform
How is the material stored?	Skip bin
Describe the construction of the elevated platform	Fully engineered concrete walls
Is there suitable guard railing to bin bays for the elevated platform?	No
Details	Guard rails have been removed at three of the five bays causing a falls hazard.
Describe the hardstand / surfacing of the general waste area	Concrete hardstand
Does the site have concrete pads beneath general waste bins?	Full concrete pads
Is the residual waste area covered?	Not covered
Can the residual waste bins be closed (e.g. with a lid or cover)	Hard cover to skips
Take photos of the general waste area, platform,

Improvements to overall management practices	Guard railing was not present at a number of general waste bays as the rails had been removed by the operator. The rails should remain up at all times.
Improvements to management of hazardous materials / dangerous goods	Collection and separation of batteries requires improvement with household batteries collected and stored loosely on the ground. The improvements to recycling infrastructure suggested previously should address this issue.
Improvements to garden organics management	At present, garden organics are stockpiled with timber and coprocessed into low grade mulch for use as landfill cover. This practice does not constitute recycling nor beneficial reuse and it is unclear how long EPA will allow it to continue at regional landfill sites.
	A long term plan for the management of timber and garden organics is required for all a Southern Grampians sites as the current procedures appear fragmented and do not support the creation of high value organic products.

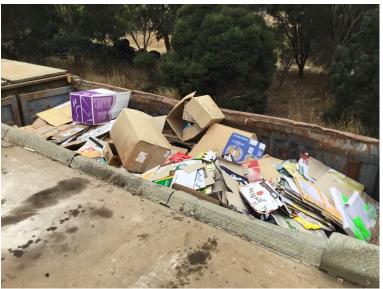
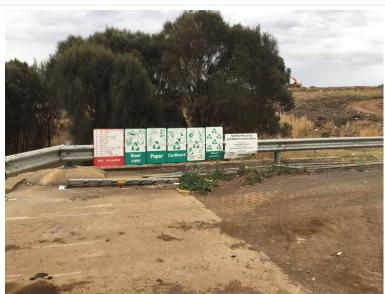
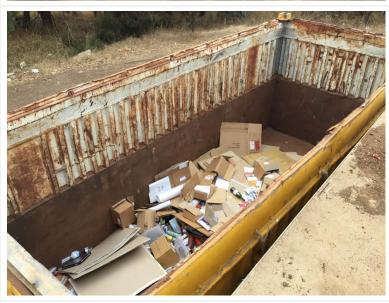
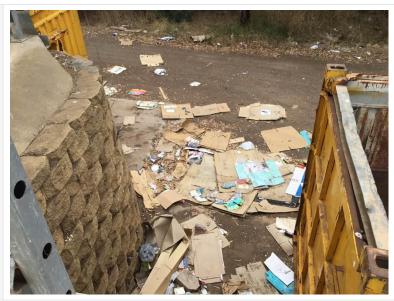
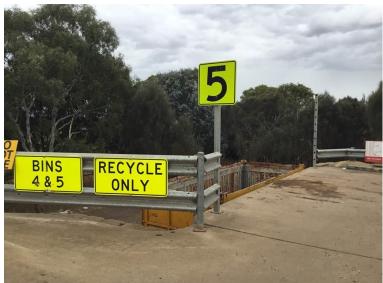
Does the site accept commingled recyclables?	Yes
How is the material stored?	Skip bin
Is it stored in a covered or uncovered area / bin?	Uncovered area
Size of the bin or storage area	Large stillage or skip bin (>20m3)
What surface is it (or its skip bin) stored on?	Full hardstand (concrete or bitumen)
Take photos of storage of this material	4 BINS 4 & 5 ONLY

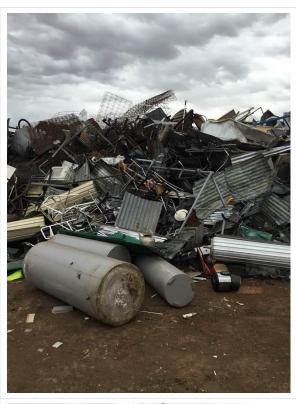
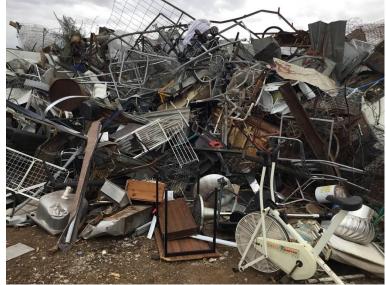
Take photos of storage of this material

Does the site accept metals?	Yes
How is the material stored?	Loose in pile
Is it stored in a covered or uncovered area / bin?	Uncovered area
Size of the bin or storage area	Large open area (e.g. metals or green waste area)
What surface is it (or its skip bin) stored on?	No hardstand (on dirt)

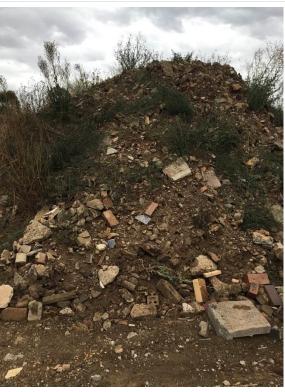
Take photos of storage of this material

Does the site accept brick / rock / rubble?	Yes
How is the material stored?	Loose in pile
Is it stored in a covered or uncovered area / bin?	Uncovered area
Size of the bin or storage area	Large open area (e.g. metals or green waste area)
What surface is it (or its skip bin) stored on?	No hardstand (on dirt)

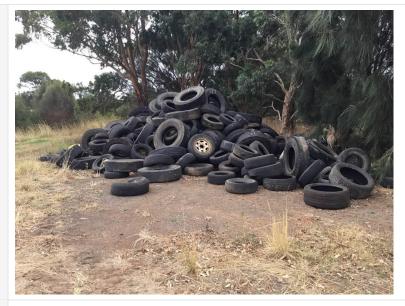
Does the site accept tyres?	Yes
How is the material stored?	Loose in pile
Is it stored in a covered or uncovered area / bin?	Uncovered area
Size of the bin or storage area	Medium stillage or skip bin (5 - 20m3)
What surface is it (or its skip bin) stored on?	No hardstand (on dirt)

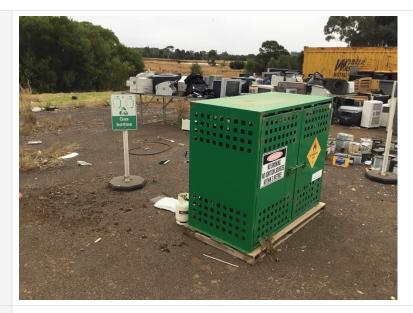
Is there any onsite processing of the material?	No
Provide details	Significant sues with storage of batteries with leakage and broken batteries evident. Needs immediate attention.

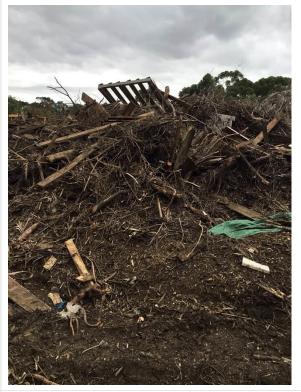
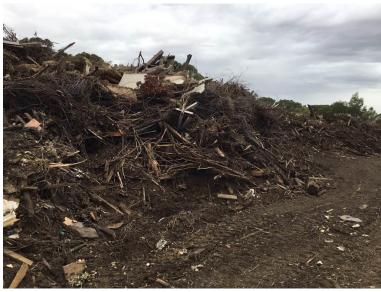
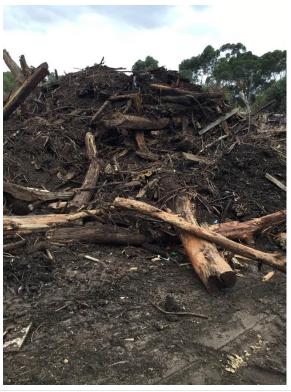
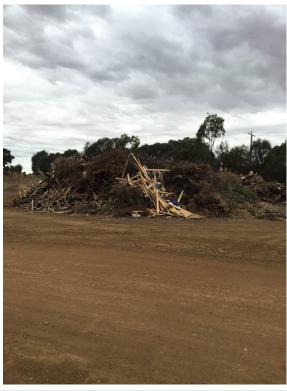
Does the site accept green waste?	Yes
How is the material stored?	Loose in pile
Is it stored in a covered or uncovered area / bin?	Uncovered area
Size of the bin or storage area	Large open area (e.g. metals or green waste area)
What surface is it (or its skip bin) stored on?	No hardstand (on dirt)
Take photos of storage of this material

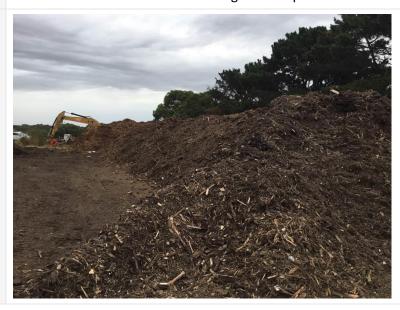
Processed regularly and used for landfill cover. Some legacy piles of material evident. Visible contamination throughout the processed material

Take a photo of the processed (mulch) green waste stockpile

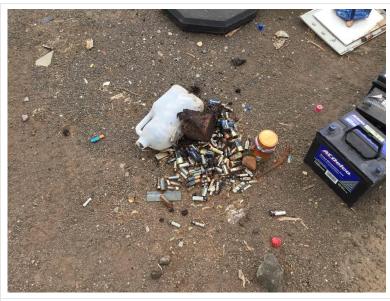
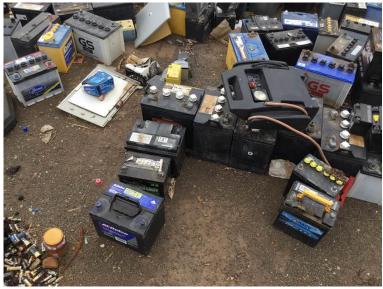
Describe general site amenity	Generally clean but some areas need improvement
Provide details	Some windblown litter arising from the landfill operation.
Is windblown litter visible outside the site or is there a history of litter issues?	Yes
Provide details	Some at and over the fence.
Is windblown litter or general debris visible within the site itself?	Yes
Are there issues with dust at the site, particularly in drier months?	Yes
Are there issues with odour at the site or have there been odour complaints?	Yes
Provide details	Landfill related.
Are there issues with noise at the site or have there been noise complaints?	No
General comments about environmental management at the site	Issues with battery storage at site with clear leakage from damaged batteries at the site.
Take photos of relevant environmental management issues

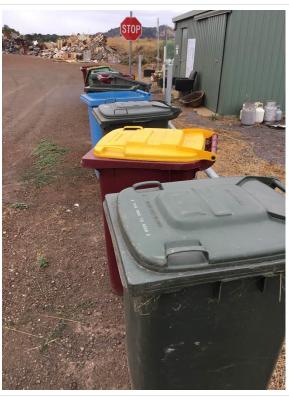
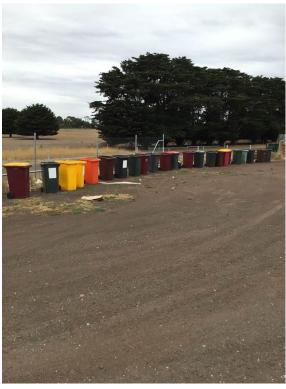
Does the site accept commingled recyclables?	Yes
How is the material stored?	Skip bin
Is it stored in a covered or uncovered area / bin?	Uncovered area
Size of the bin or storage area	Large open area (e.g. metals or green waste area)
What surface is it (or its skip bin) stored on?	No hardstand (on dirt)

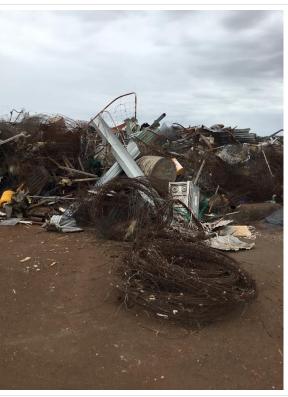
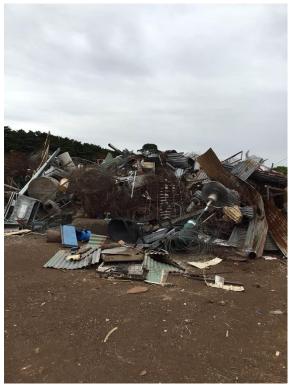
Does the site accept metals?	Yes
How is the material stored?	Loose in pile
Is it stored in a covered or uncovered area / bin?	Uncovered area
Size of the bin or storage area	Large open area (e.g. metals or green waste area)
What surface is it (or its skip bin) stored on?	No hardstand (on dirt)

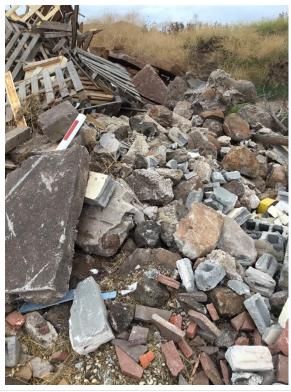
Does the site accept concrete?	Yes
How is the material stored?	Loose in pile
Is it stored in a covered or uncovered area / bin?	Uncovered area
Size of the bin or storage area	Large open area (e.g. metals or green waste area)
What surface is it (or its skip bin) stored on?	No hardstand (on dirt)

Is there any onsite processing of the material?	Yes
Provide details	Intention is to crush this and use it onsite

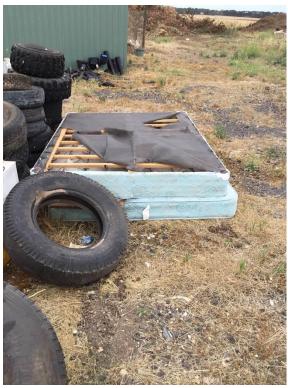
Does the site accept mattresses?	Yes
How is the material stored?	Loose in pile
Is it stored in a covered or uncovered area / bin?	Uncovered area
Size of the bin or storage area	Large open area (e.g. metals or green waste area)
What surface is it (or its skip bin) stored on?	No hardstand (on dirt)

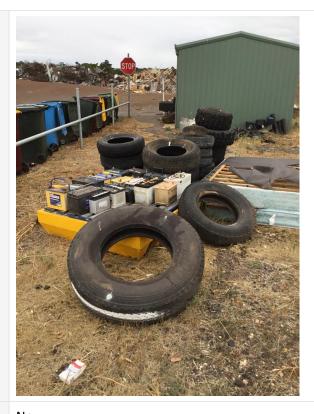
Does the site accept tyres?	Yes
How is the material stored?	Loose in pile
Is it stored in a covered or uncovered area / bin?	Uncovered area
Size of the bin or storage area	Large open area (e.g. metals or green waste area)
What surface is it (or its skip bin) stored on?	No hardstand (on dirt)

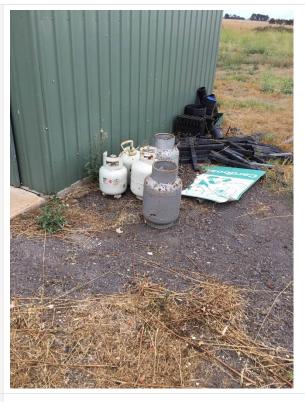
Does the site accept gas bottles?	Yes
How is the material stored?	Loose in pile
Is it stored in a covered or uncovered area / bin?	Uncovered area
Size of the bin or storage area	Large open area (e.g. metals or green waste area)
What surface is it (or its skip bin) stored on?	No hardstand (on dirt)
Is the material stored in a manner that is required under the relevant regulations (e.g. bunding, fully enclosed, weatherproof etc.)?	No

Upgrades required to hazardous materials / dangerous goods storage	Batteries and gas bottles are stored in a manner which is not compliant with better practice guidelines. New infrastructure is required such as a secure shed with hardstand.
Improvements to roads and hardstand areas	The site would benefit from improved hardstands and linemarking in the medium to long term.

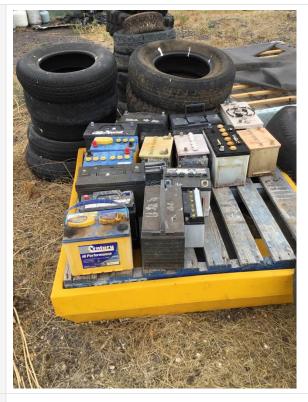
Does the site accept lead- acid batteries?	Yes
How is the material stored?	Loose in pile
Is it stored in a covered or uncovered area / bin?	Uncovered area
Size of the bin or storage area	Large open area (e.g. metals or green waste area)
What surface is it (or its skip bin) stored on?	No hardstand (on dirt)
Is the material stored in a manner that is required under the relevant regulations (e.g. bunding, fully enclosed, weatherproof etc.)?	No

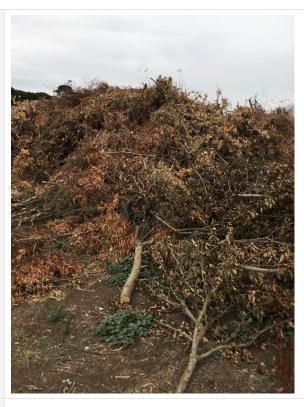
Is the green waste drop-off area visible from the gatehouse?	Yes
Does water drain from the green waste area (visually or reportedly, look for pools of water)?	Yes
Is storm water runoff and leachate actively managed from the green waste area?	No
