Coleraine Flood Investigation Final Summary Report

Reference: R.M000136.008.04
Date: April 2019

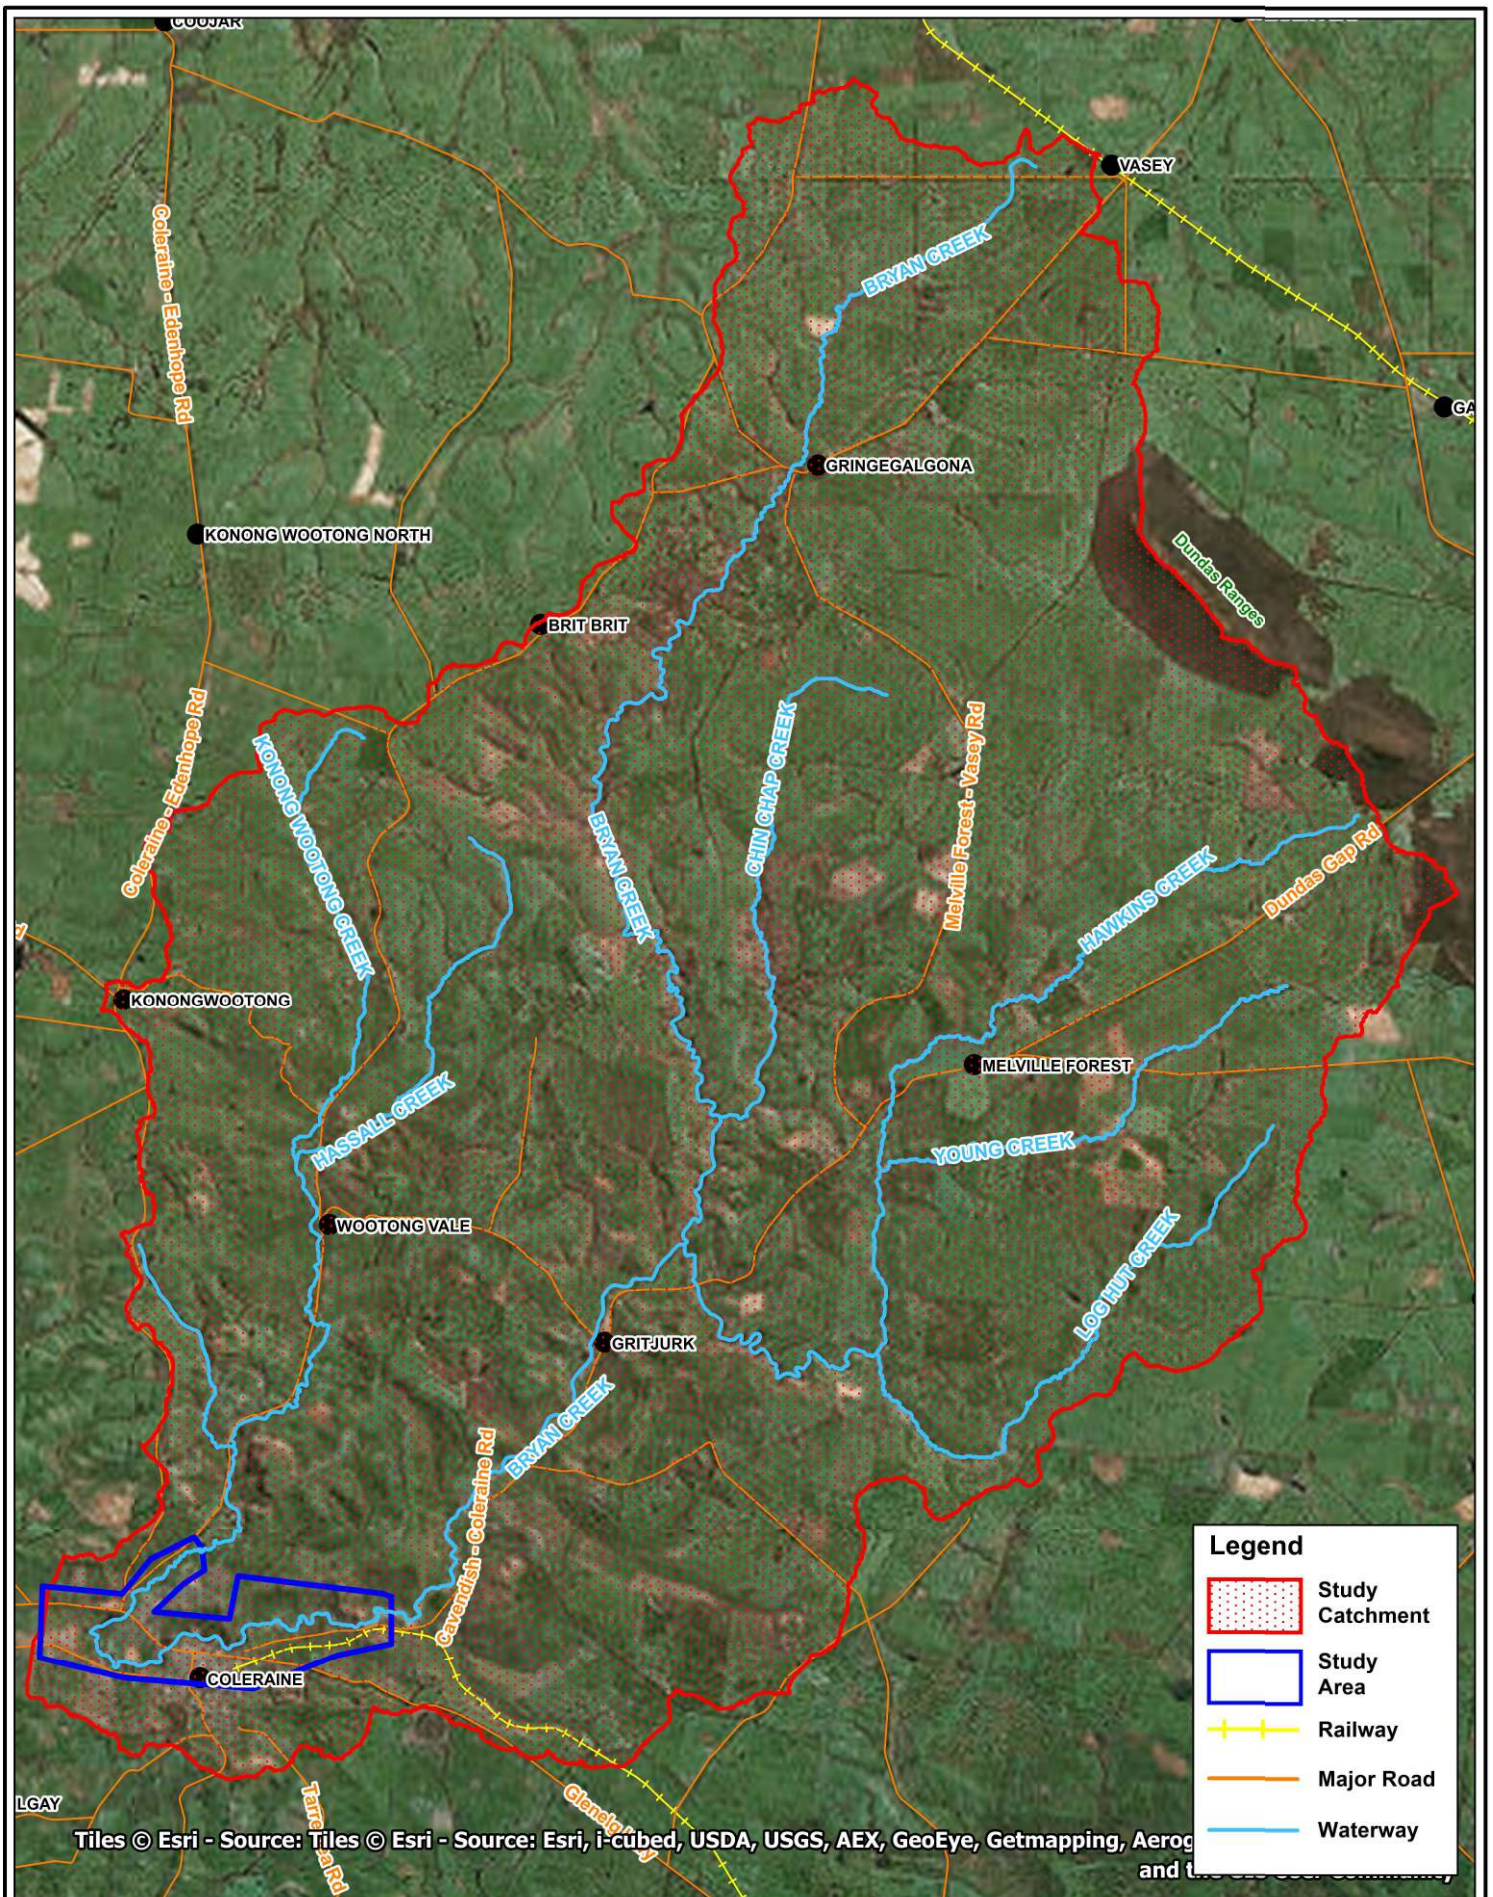
Figure: 1-1
Rev: A
N 0 2.5 5km
Approx. Scale

Title: Coleraine Flood Investigation
Study Catchment

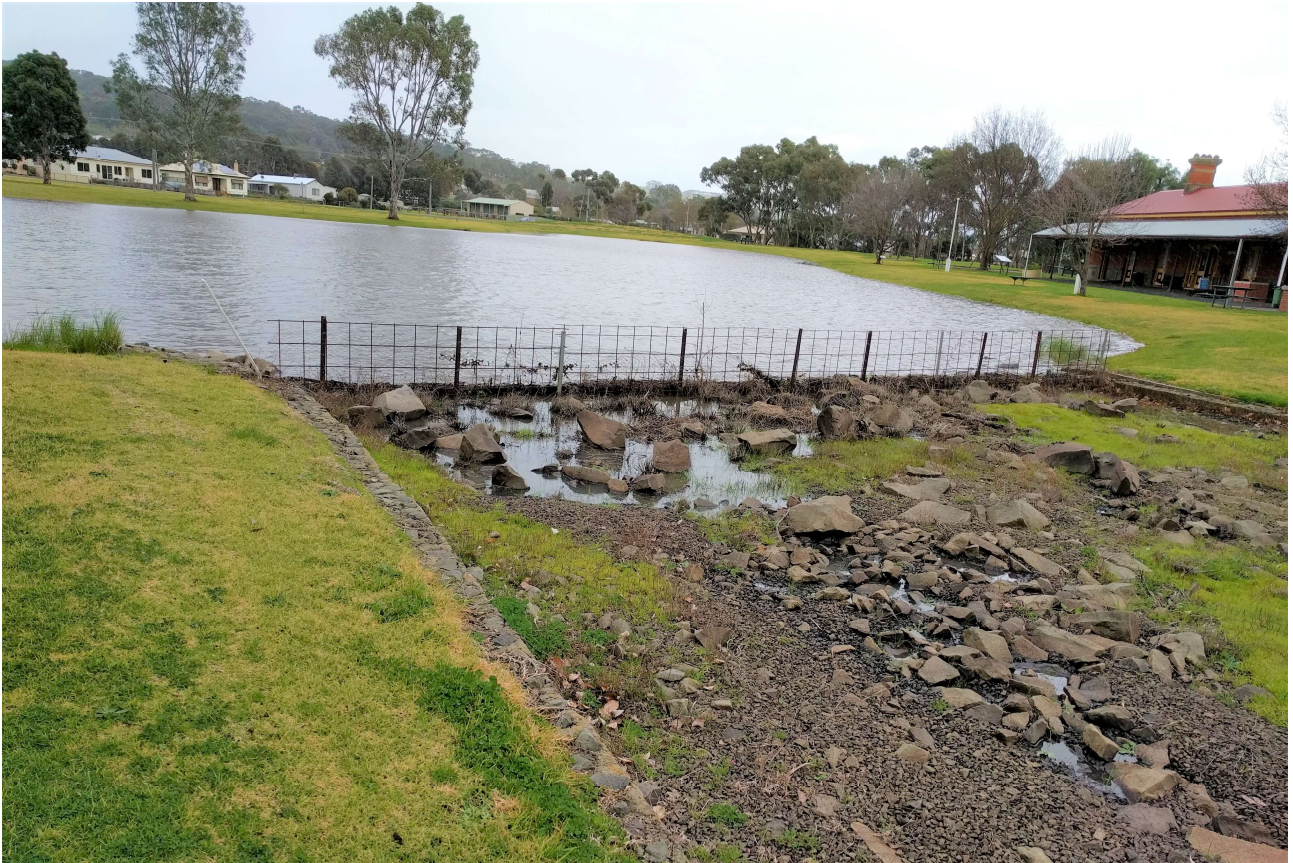
Figure 1-2 Young Street Lake and Spillway

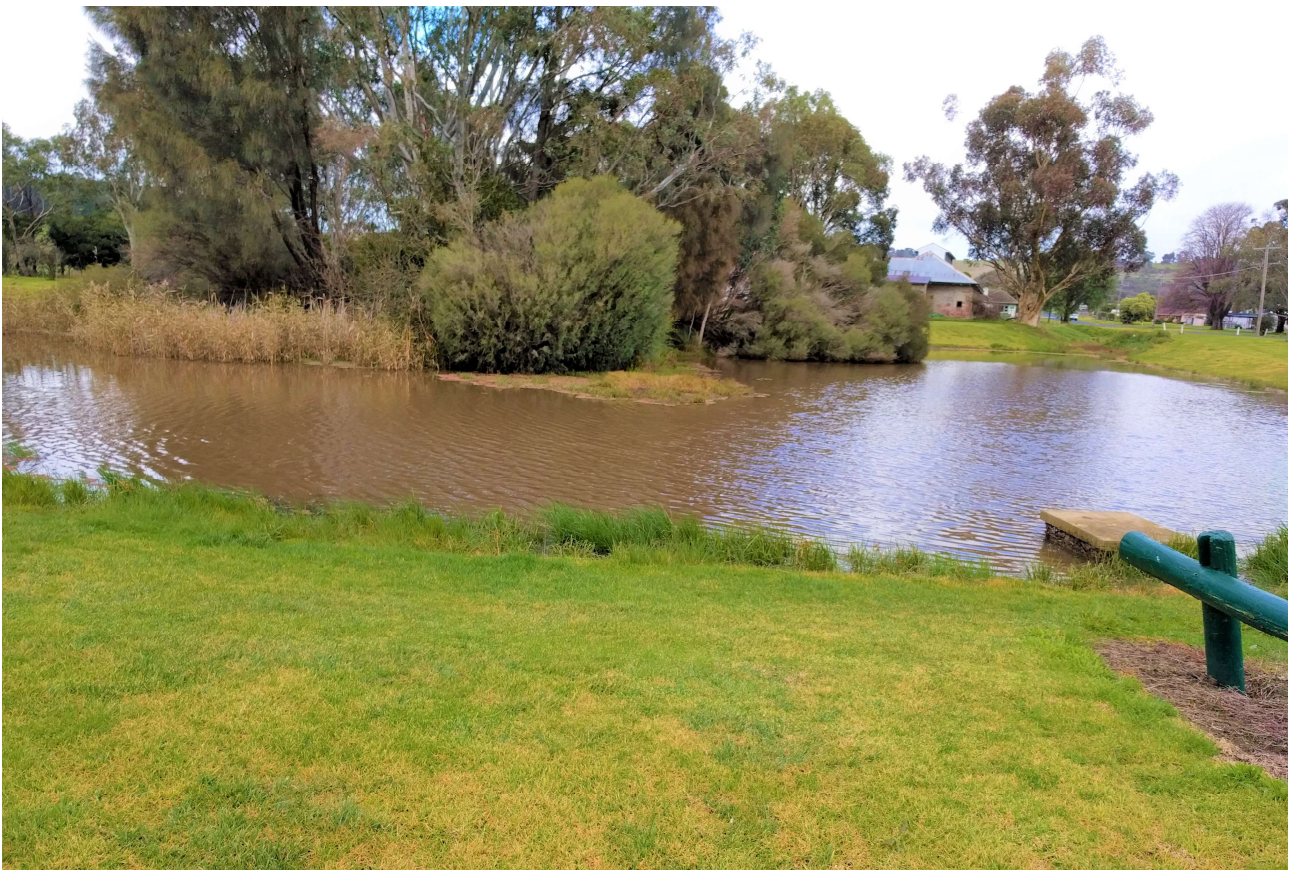
Figure 1-3 Robertson Street Lake and Outlet Control (concrete box in front of green fence)

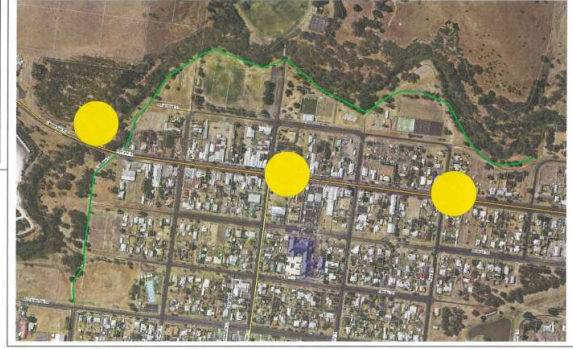
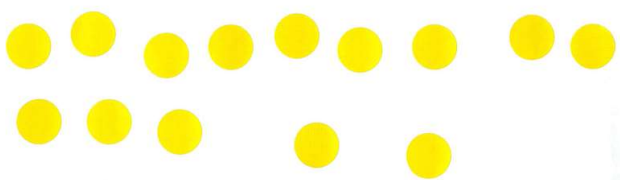
Figure 2-2 Example Mitigation Voting Sheet from the 2nd Community Engagement Meeting

LEVEE BANK GENERALLY ALIGNED WITH THE BRYAN CREEK WALKING TRACK – MEETING UP WITH LAIDLAW STREET

This would make use of the existing walking track, raising low points and connecting high points to create a continuous embankment. The technical feasibility of joining to Laidlaw Street would need to be verified.

The community was also asked for their thoughts on any mitigation options that they would like to see investigated further. A list of options was then compiled and voted upon by the community, an example voting sheet is shown in Figure 2-2. These were collated and discussed with the PRG at the conclusion of the meeting and led to the adoption of five options for further investigation.

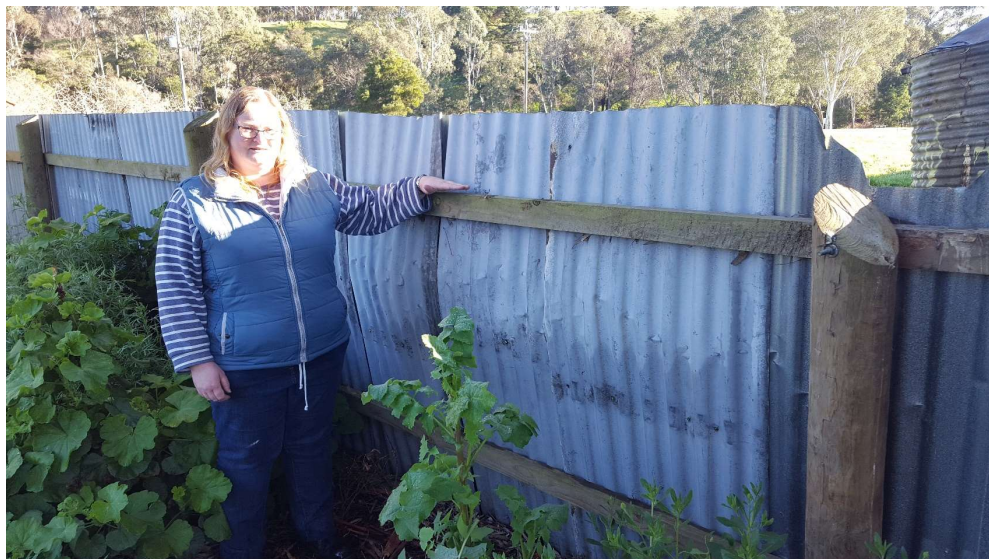
Figure 3-3 Teagan Beaton showing flood level at 108 Whyte St

In the image above – Teagan is pointing out the peak level of the floodwater on the fence in the backyard. Bryan Creek is about 500 m behind this fence and the curvature on the iron was caused by the force of floodwater against it. Teagan and James have provided numerous photos from the flood. The damage is still evident today as is the height of the floodwater in the house.

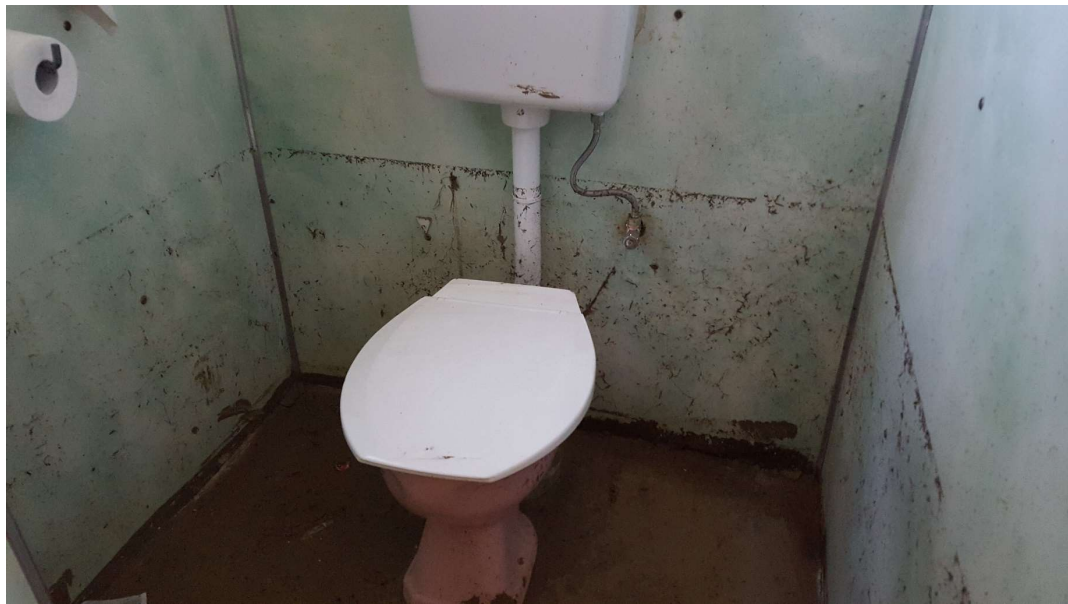
Figure 3-4 Flood Mark Visible at 108 Whyte St

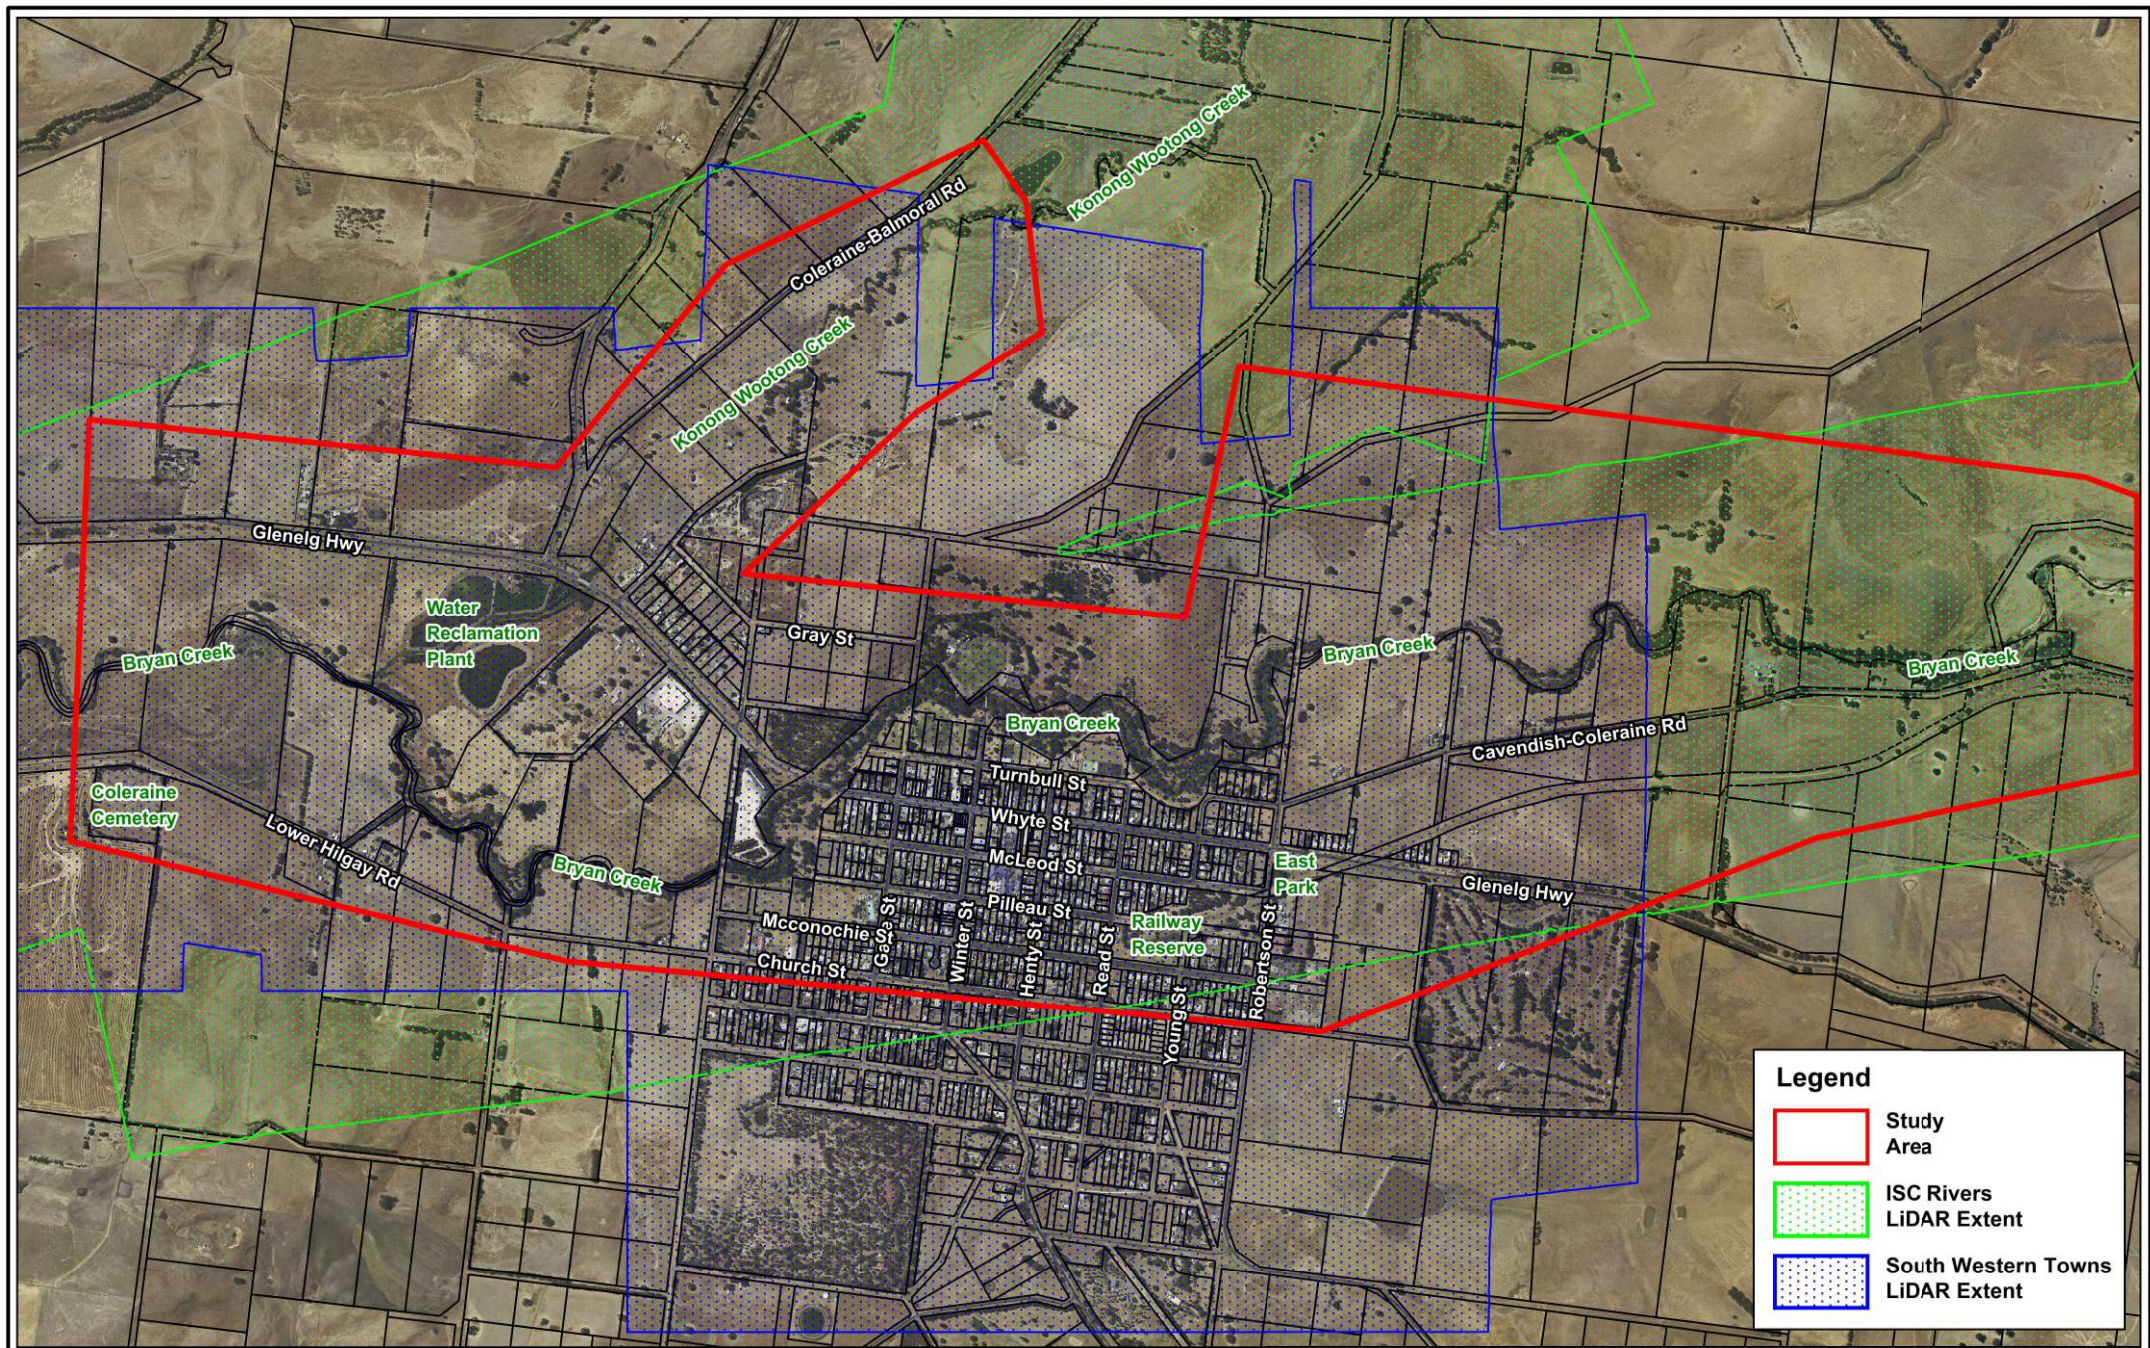
Figure:
3-5

Title: Coleraine Flood Investigation
Study Area and LiDAR Coverage

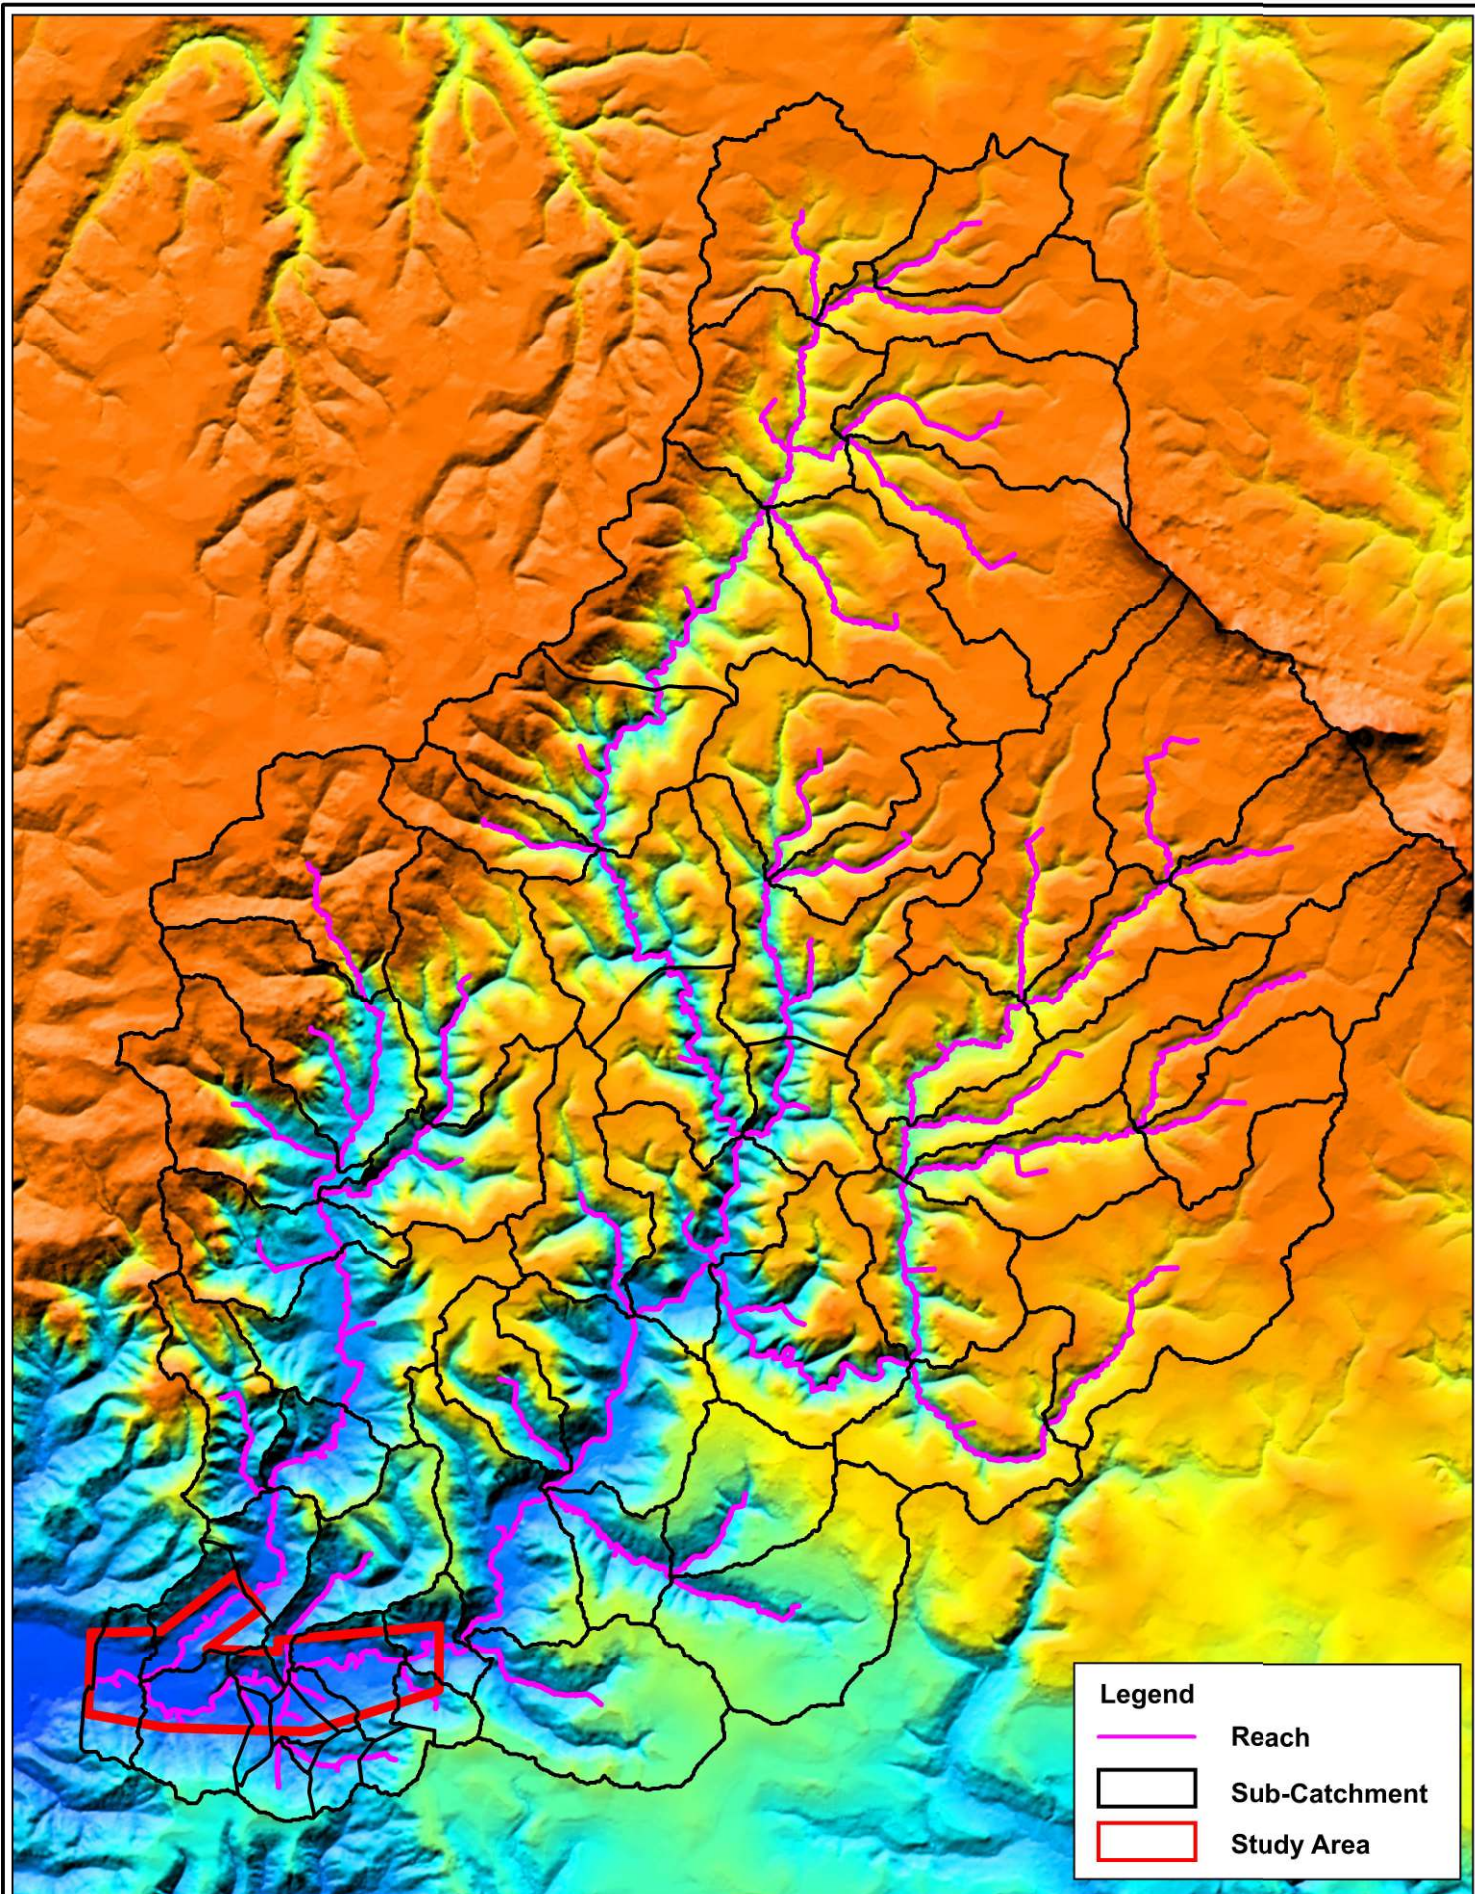
Figure: 4-1 Rev: A

Title: Coleraine Flood Investigation
RORB Model Schematisation

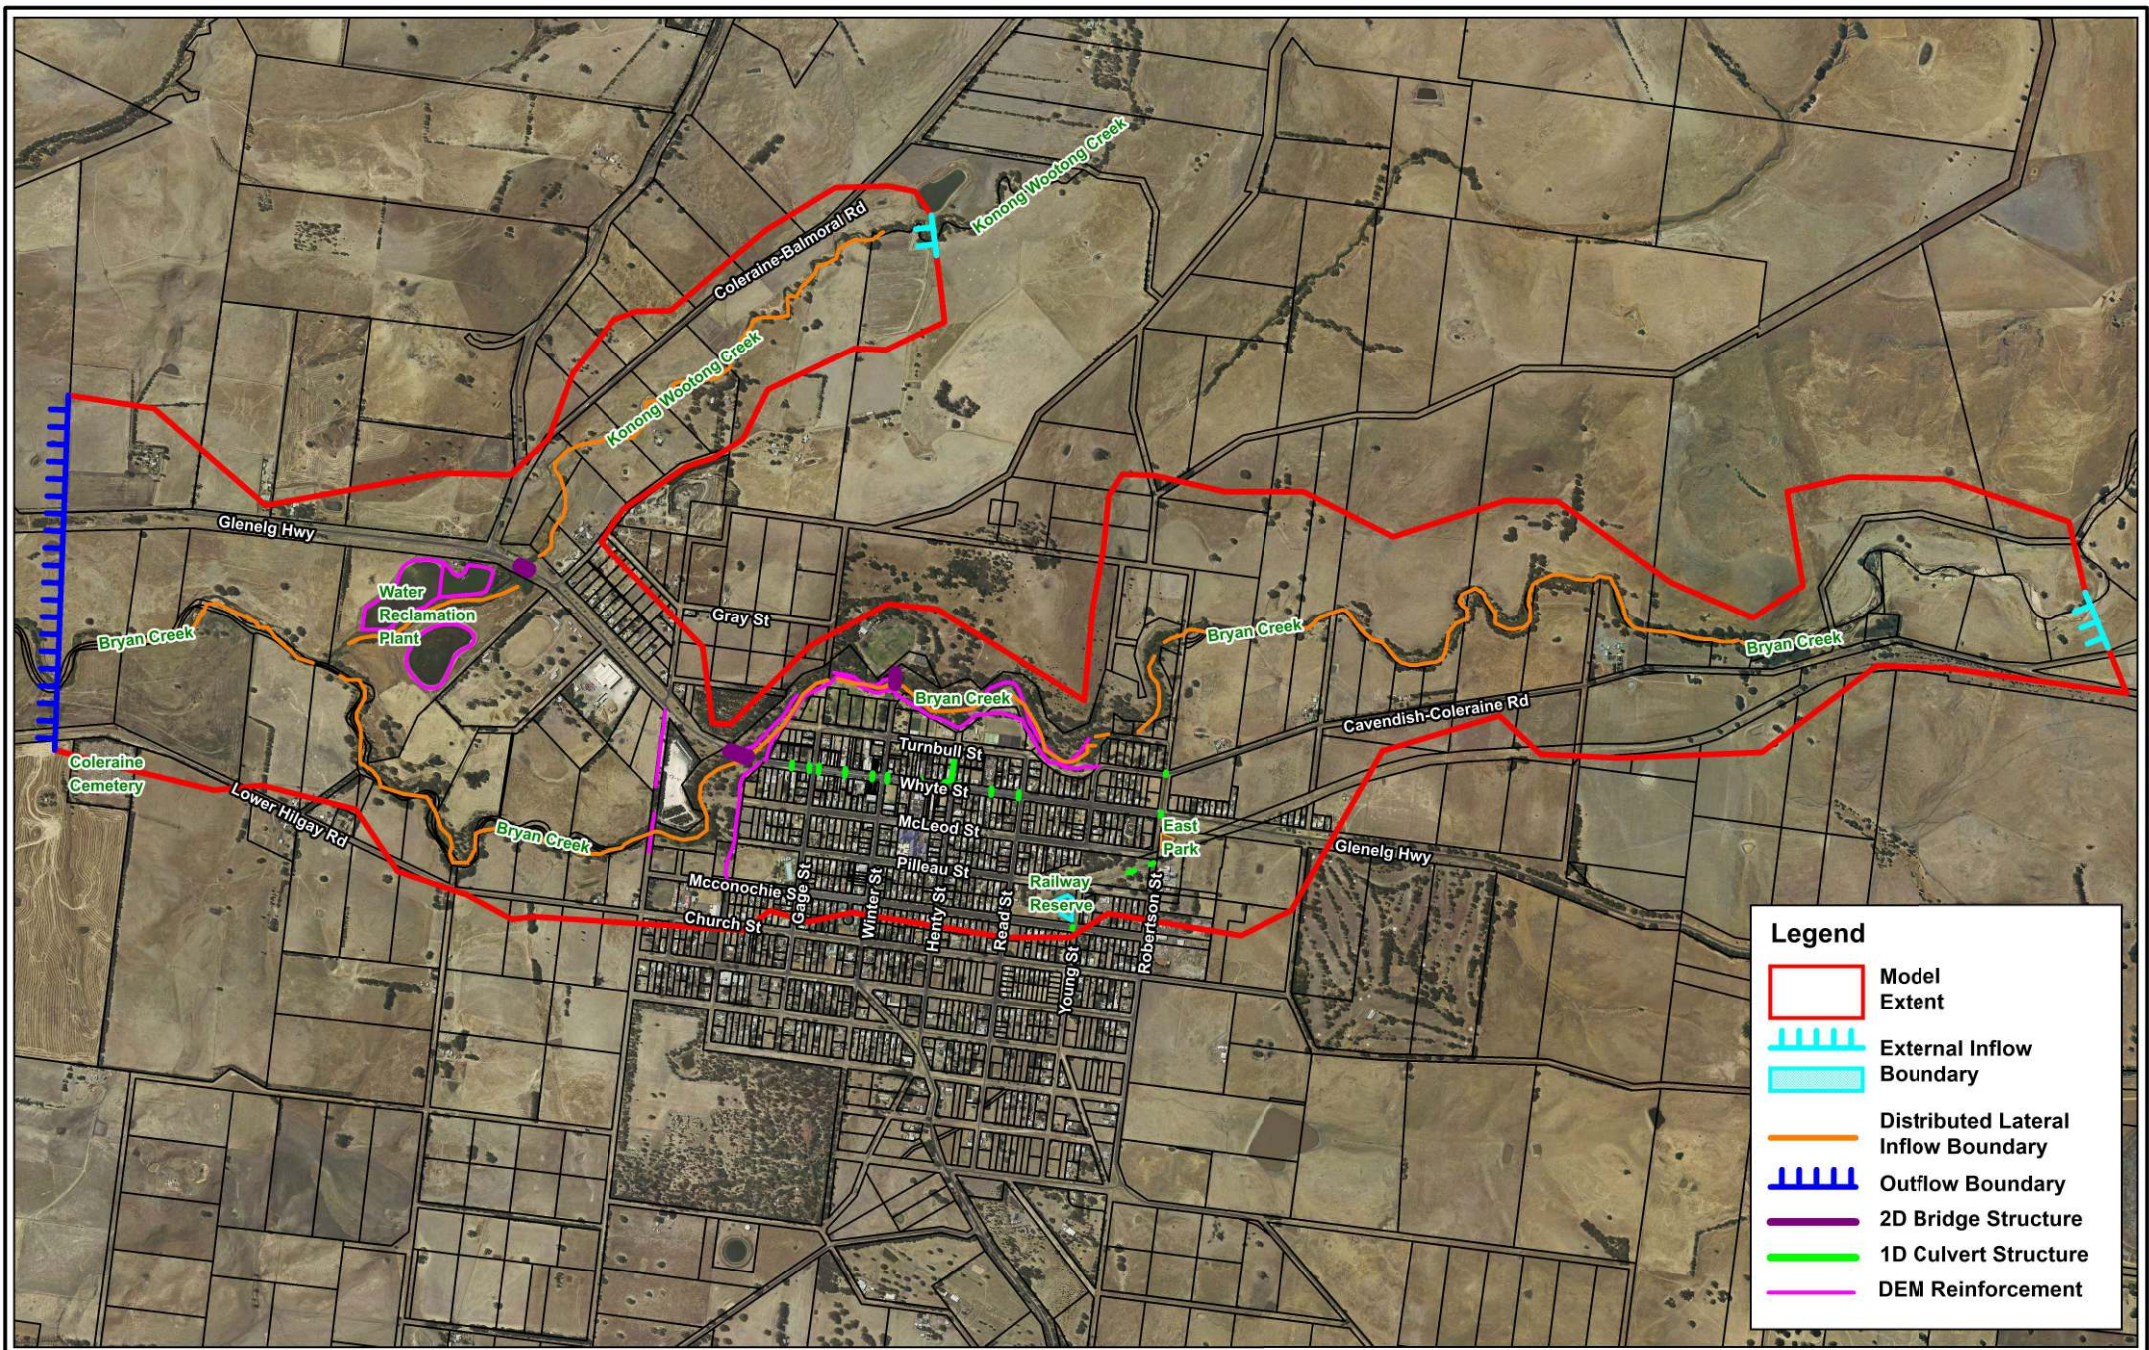
Figure:
4-2

Title: Coleraine Flood Investigation
TUFLOW Schematisation

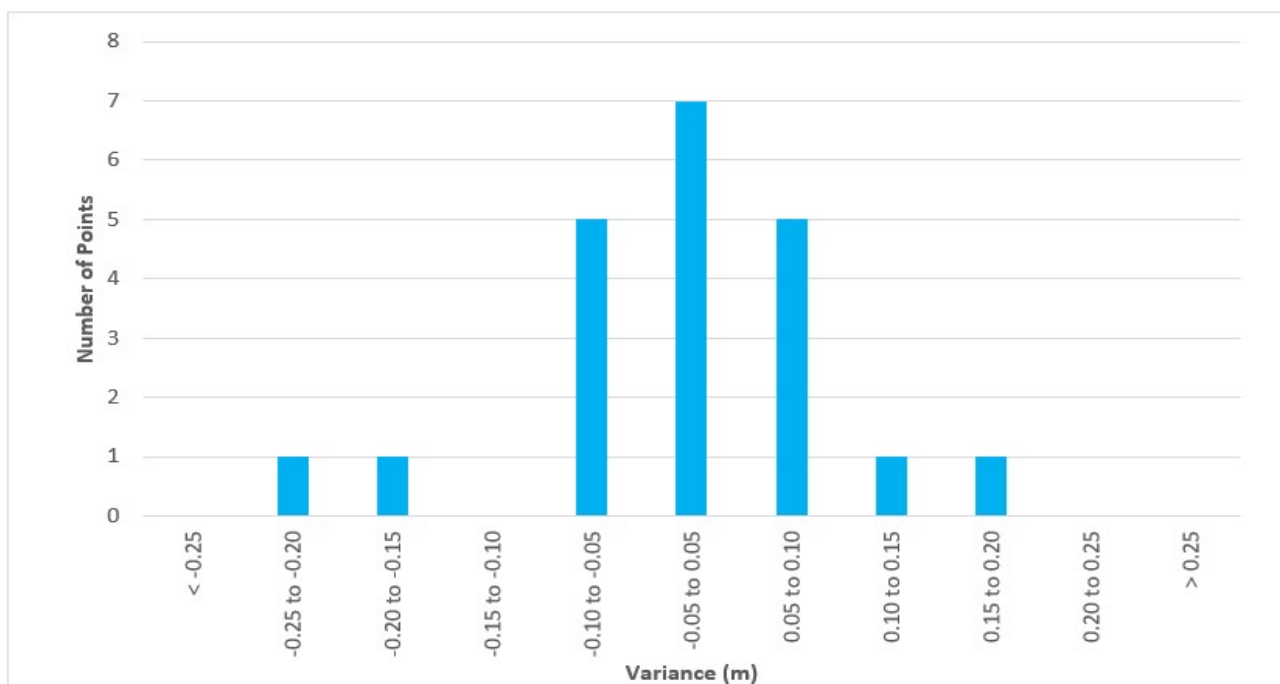
Figure 4-3 Histogram of Observed and Modelled Flood Levels - 2016 Flood Event

Table 4-3 Statistical Comparison of Observed and Modelled Flood Levels - 2016 Flood Event

Data Source	Modelled - Observed
No. of PSM points	21
Mean (m)	0.00
Median (m)	0.02
Standard Deviation (m)	0.09
Lower Quartile (m)	-0.07
Upper Quartile (m)	0.06

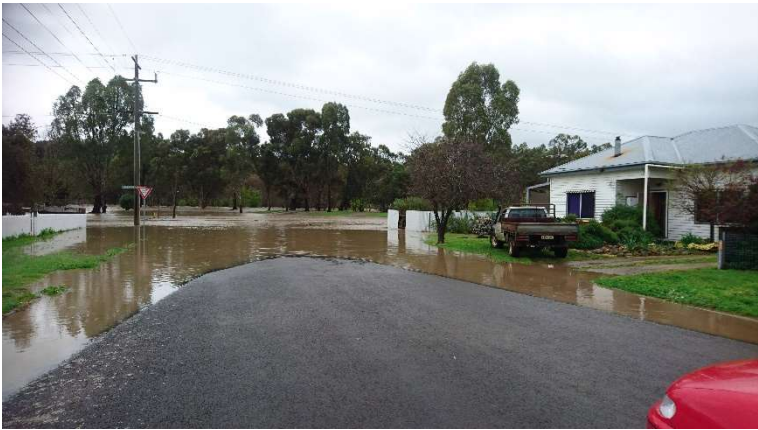
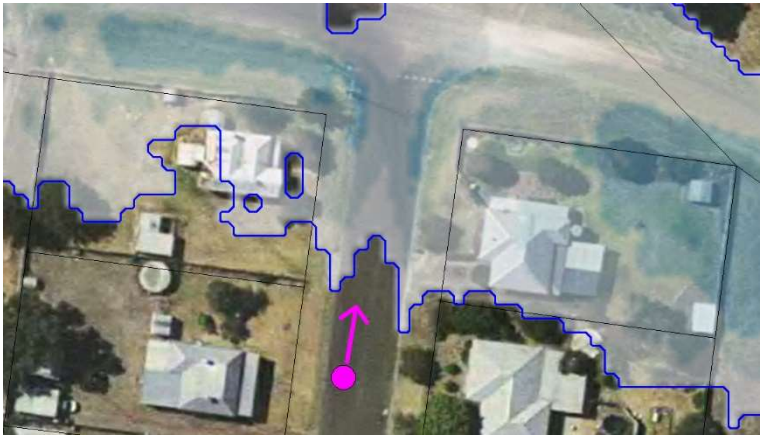
Description	Photography	Flood Model Extent
<p>Flooding at the intersection of Read and Turnbull St. Photo taken in front of 5 Read St looking towards Bryan Creek.</p> <p>Both model and photo show flooding over the crown of the road approximately in line with the driveway of 2 Read St.</p> <p>Photo provided by Jac Bailey.</p>

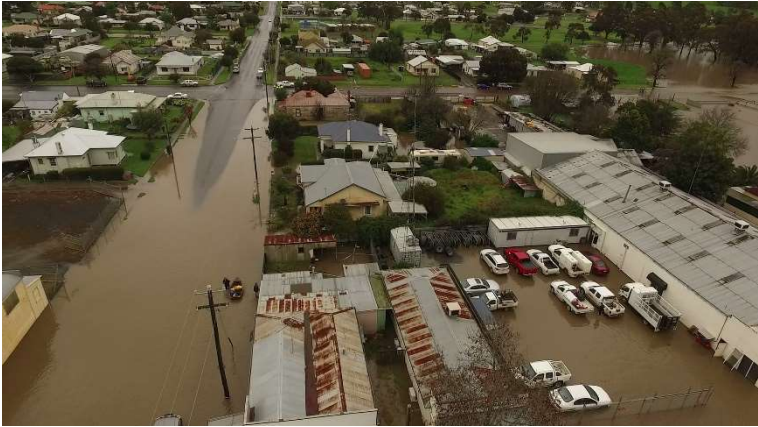
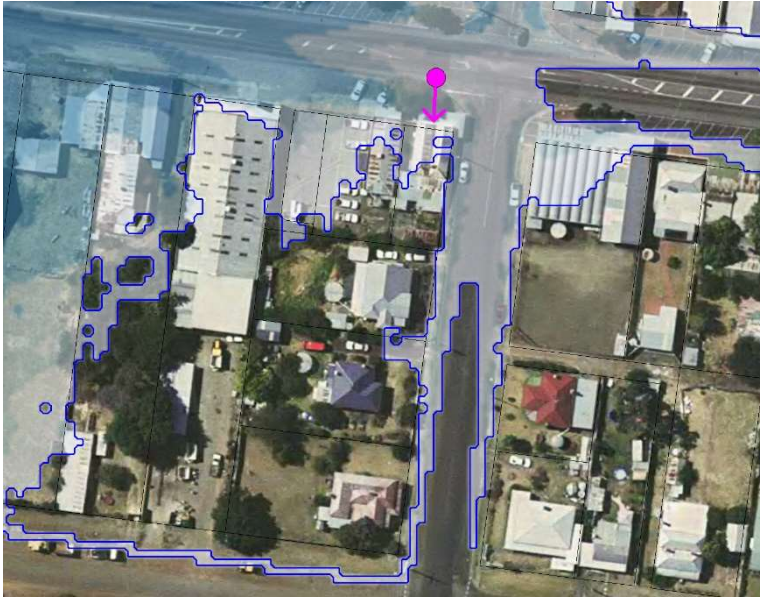
<p>Flooding along Gage St, taken above Whyte St.</p> <p>Model matching drone footage. Flood waters extend up to McLeod St with the crown being crossed in front of 15 Gage St.</p> <p>Flooding also matching at the carpark between 103 and 105 Whyte St.</p> <p>Drone footage provided by David Vickery</p>

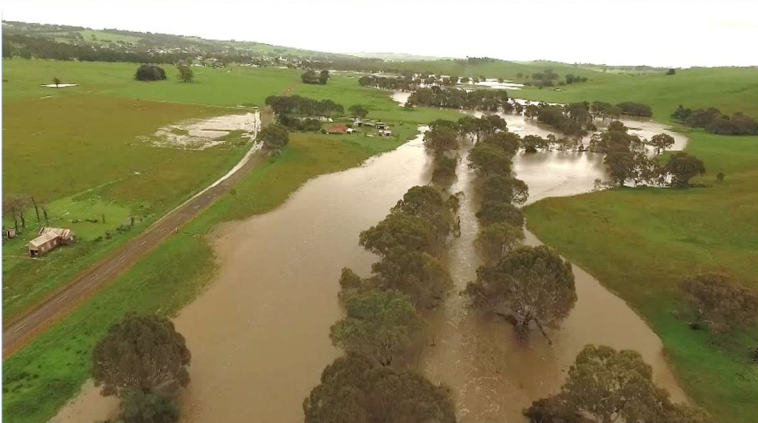
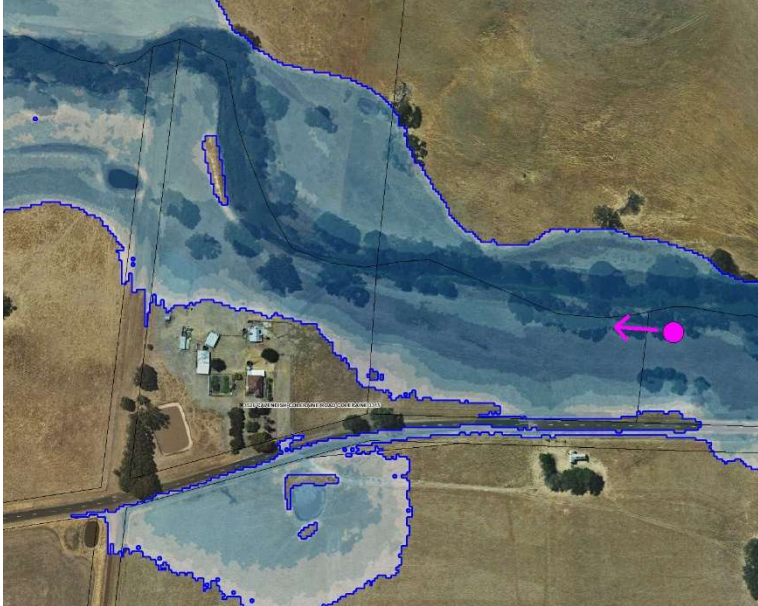
Description	Photography	Flood Model Extent
<p data-bbox="163 212 474 331">Flooding near 3526 Cavendish-Coleraine Road. Note: drone footage taken after peak.</p> <p data-bbox="163 383 474 718">Model matching drone footage well. On the northern (right) side of the images the flood waters extend to the two trees clearly visible in the aerial photography in the flood model results. Evidence of flooding to the south of Cavendish-Coleraine Road.</p> <p data-bbox="163 769 474 825">Drone footage provided by David Vickery</p>

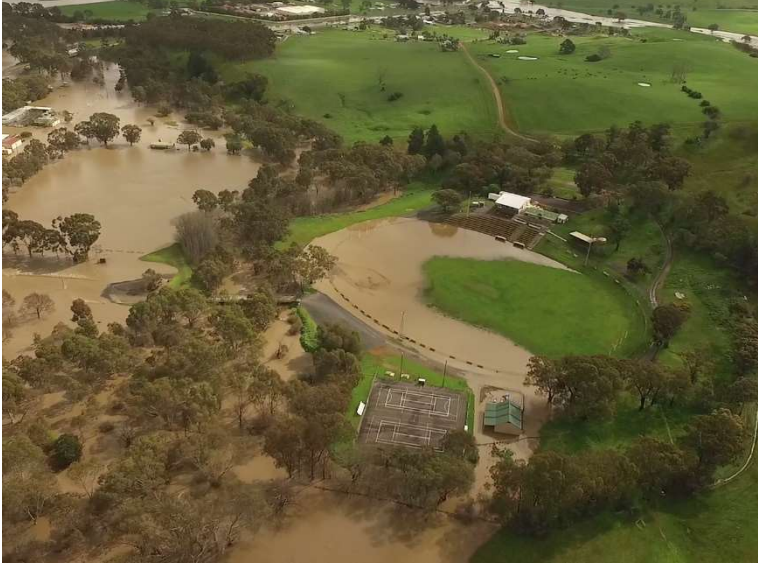
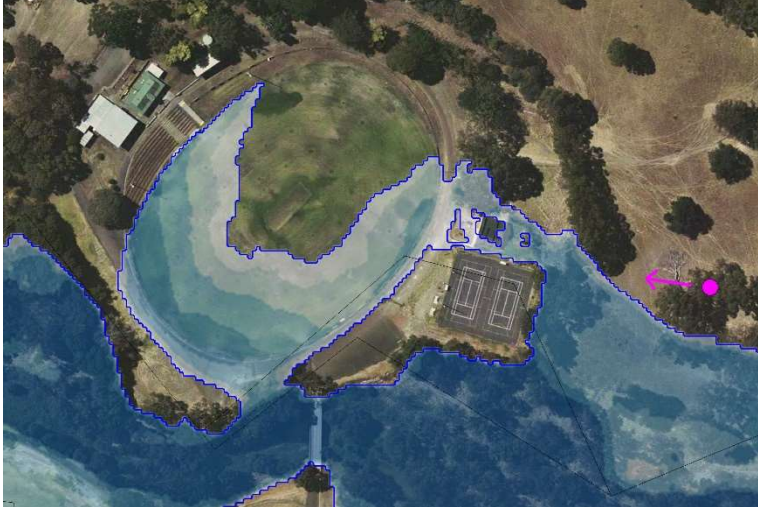
<p data-bbox="163 850 474 938">Flooding of Queens Park Oval. Note: drone footage taken after peak.</p> <p data-bbox="163 989 474 1324">Model matching drone footage well. Floodwaters flowing around tennis courts. Flood waters within the oval extend on the pitch in a crescent up to the northern most building. Flood waters re-join Bryan Creek in the area immediately after Winter St bridge.</p> <p data-bbox="163 1375 474 1431">Drone footage provided by David Vickery</p>
