Coleraine Flood Investigation Final Summary Report

Reference: R.M000136.008.04
Date: April 2019

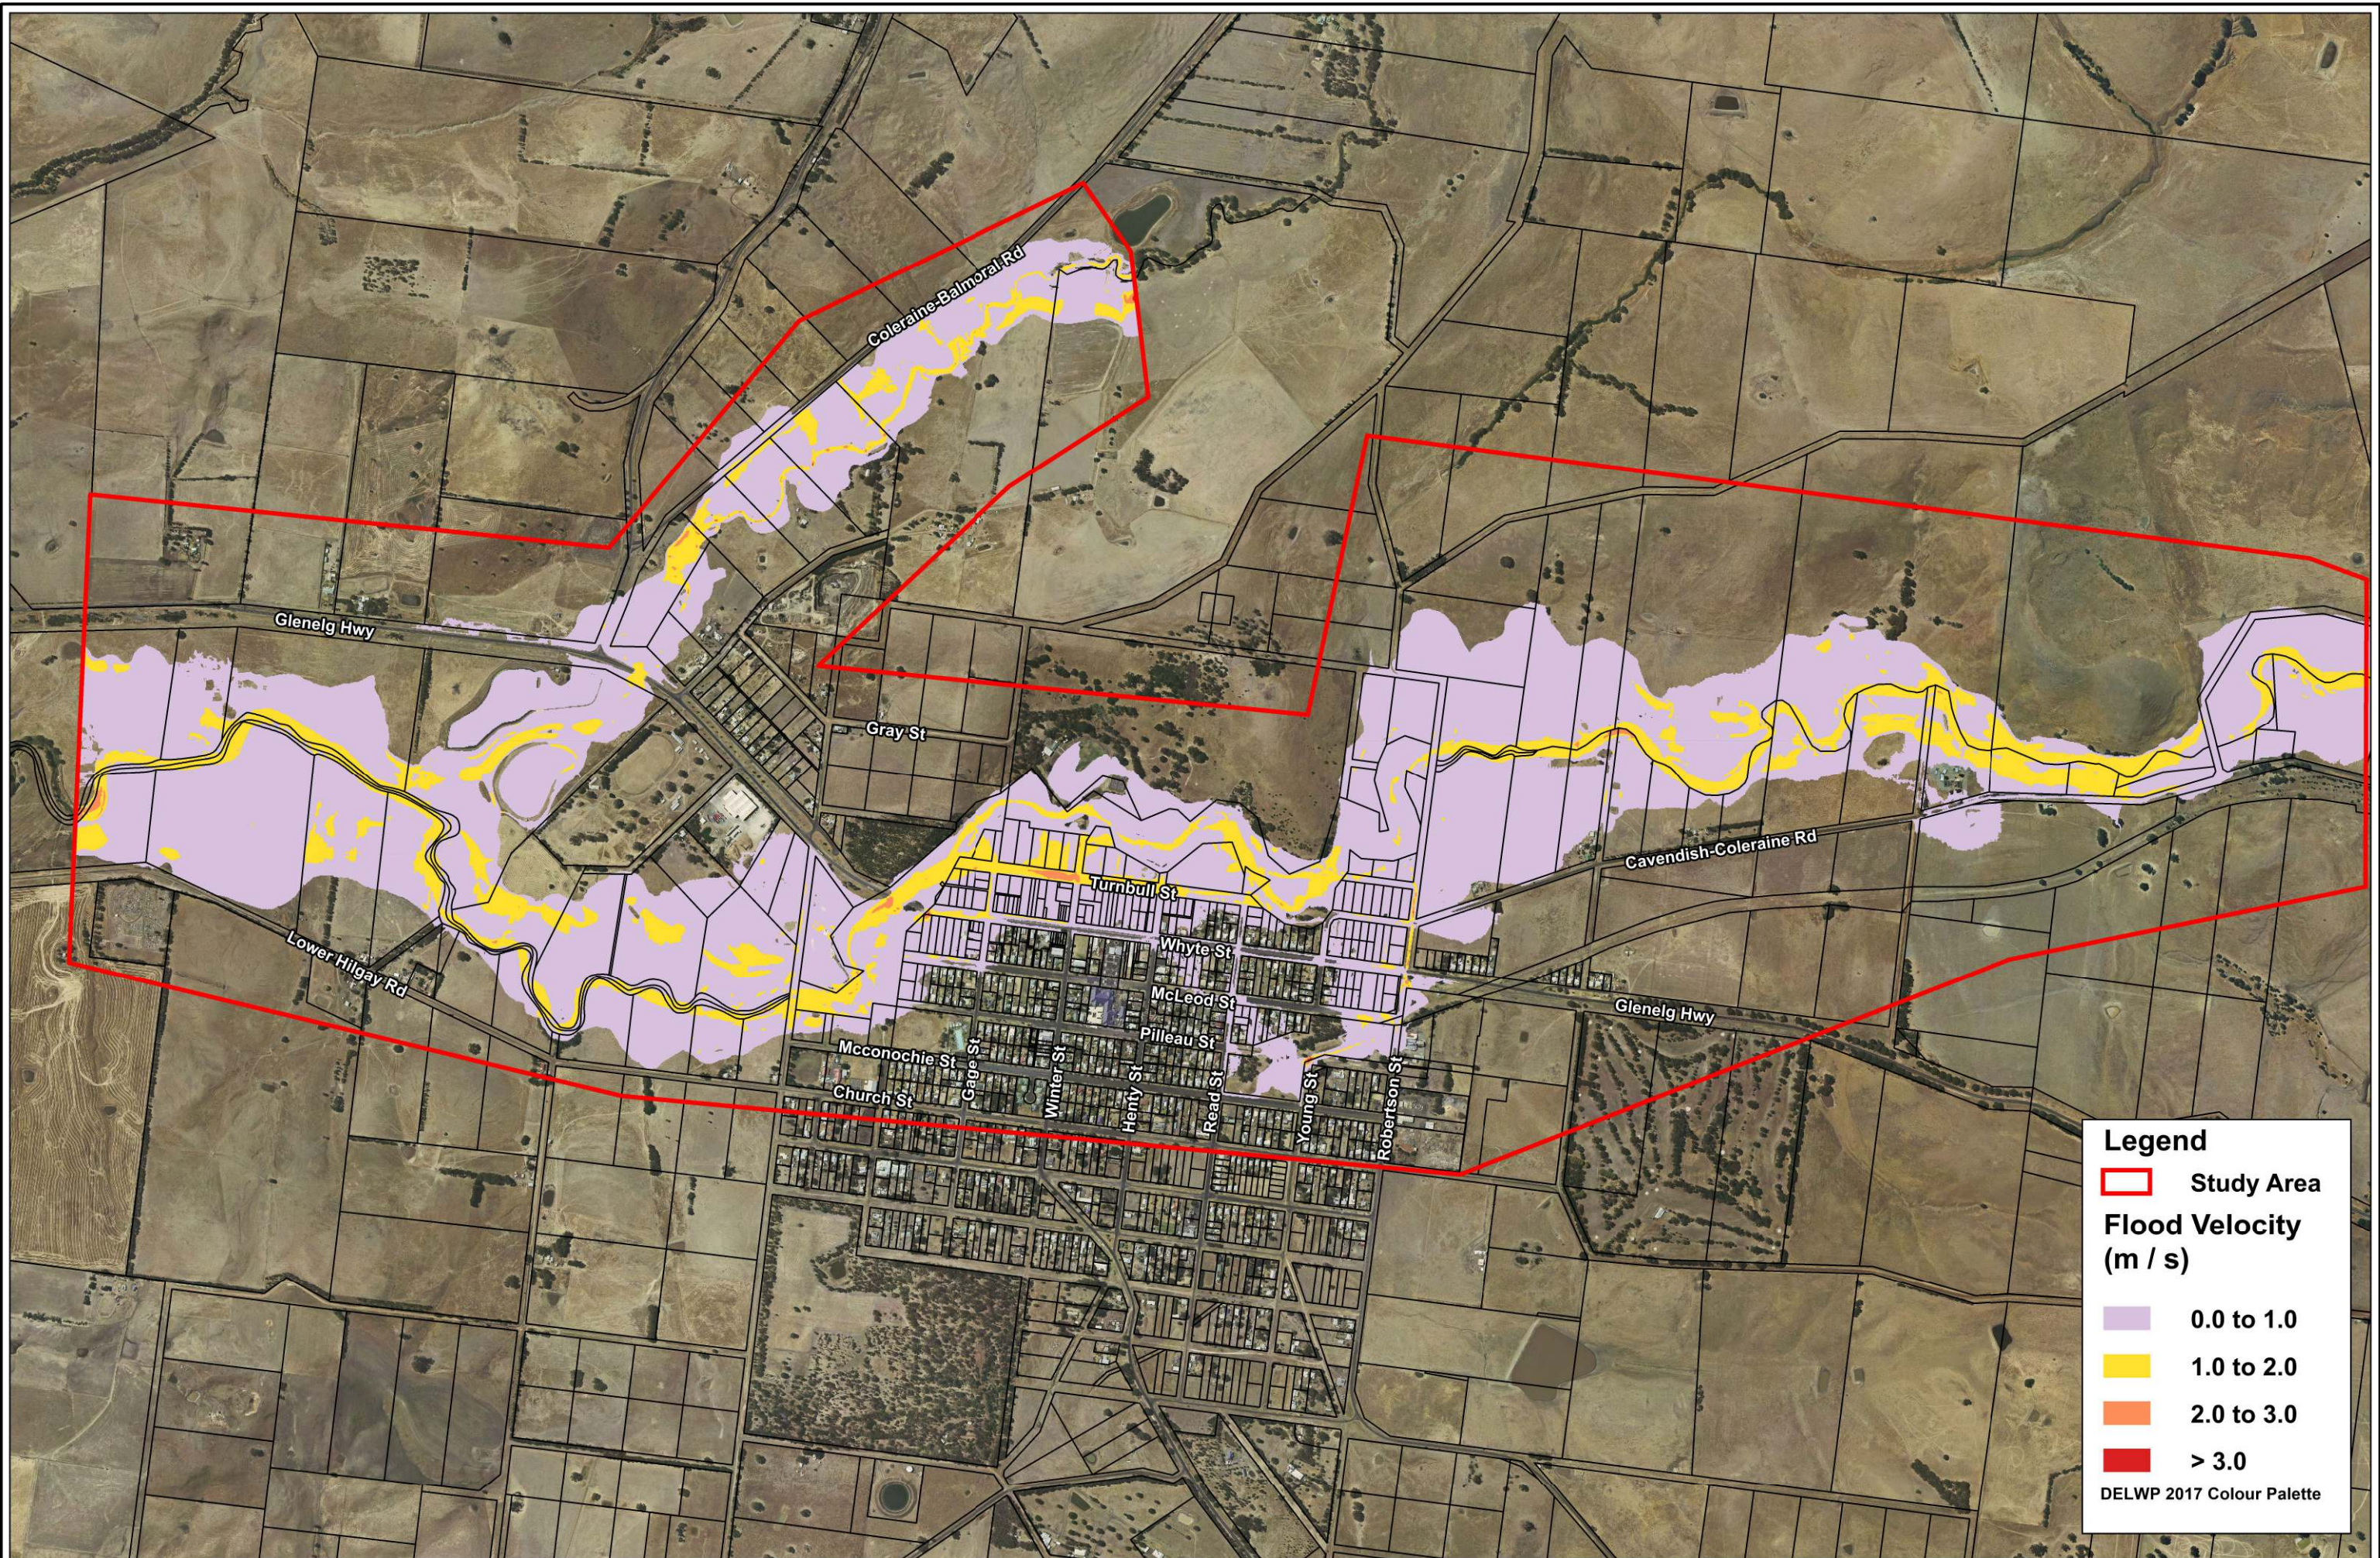
Figure:
4-9

Flood mapping of the velocity at peak flood levels for the 1% AEP flood event under existing conditions is presented in Figure 4-9, the remainder of the flood velocity maps are provided in the hydraulic model report (Venant Solutions 2018b) and as GIS layers.

Unsurprisingly the areas with highest hazard are along Bryan and Konong-Wootong Creeks and along Turnbull St due to both high velocity and depths. Based on DELWP 2017 classification these areas are considered 'extreme' hazard.

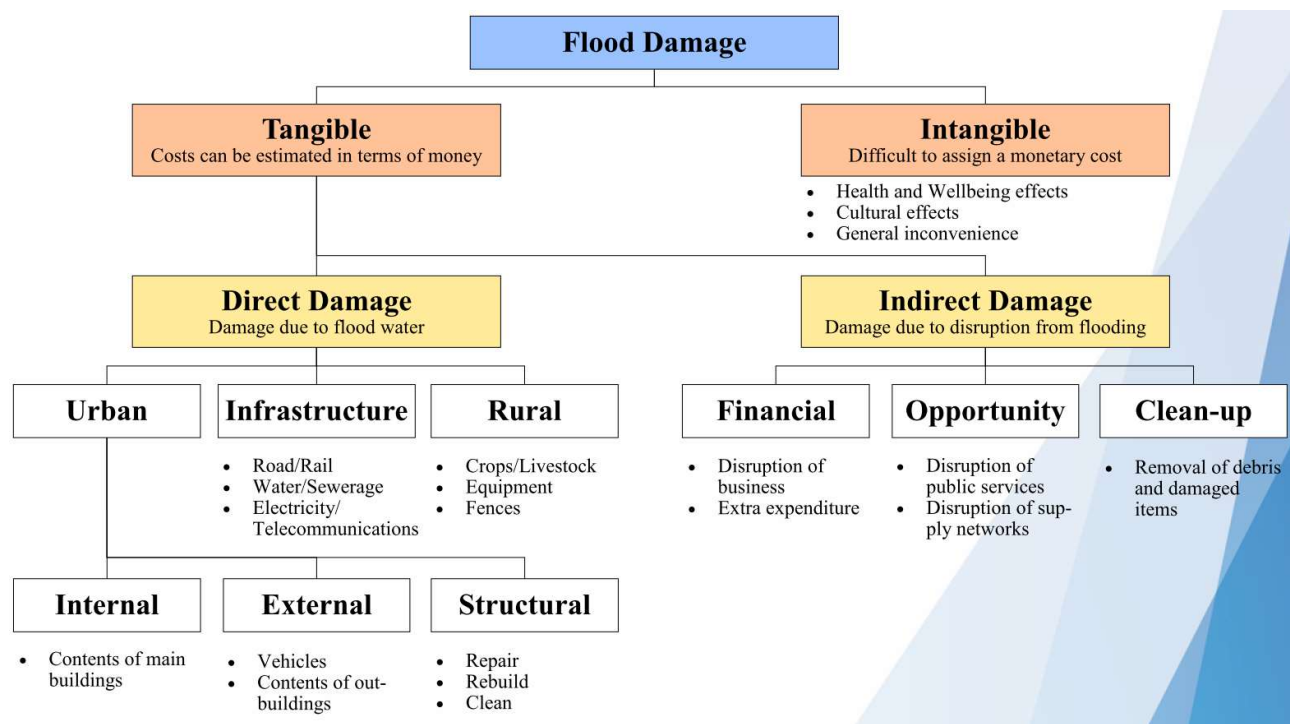
For the purposes of assessment, flood damage is classified in several ways as outlined in Figure 5-1 below. The two primary divides in flood damage are that between tangible and intangible damages and the divide between direct and indirect costs. A cost is defined as intangible where there is difficulty assigning a dollar value to that damage. For example, the effects on a person's mental health of a flood destroying their house are far more difficult to quantify than the damage the house itself suffered. Direct damage is that caused to physical objects by the flood water, where indirect damage is caused by disruptions to economic and physical activity. An example of indirect damage would be a store surrounded by the flood but not inundated; it cannot service customers so potential income is lost.

Figure 5-1 Types of Flood Damage

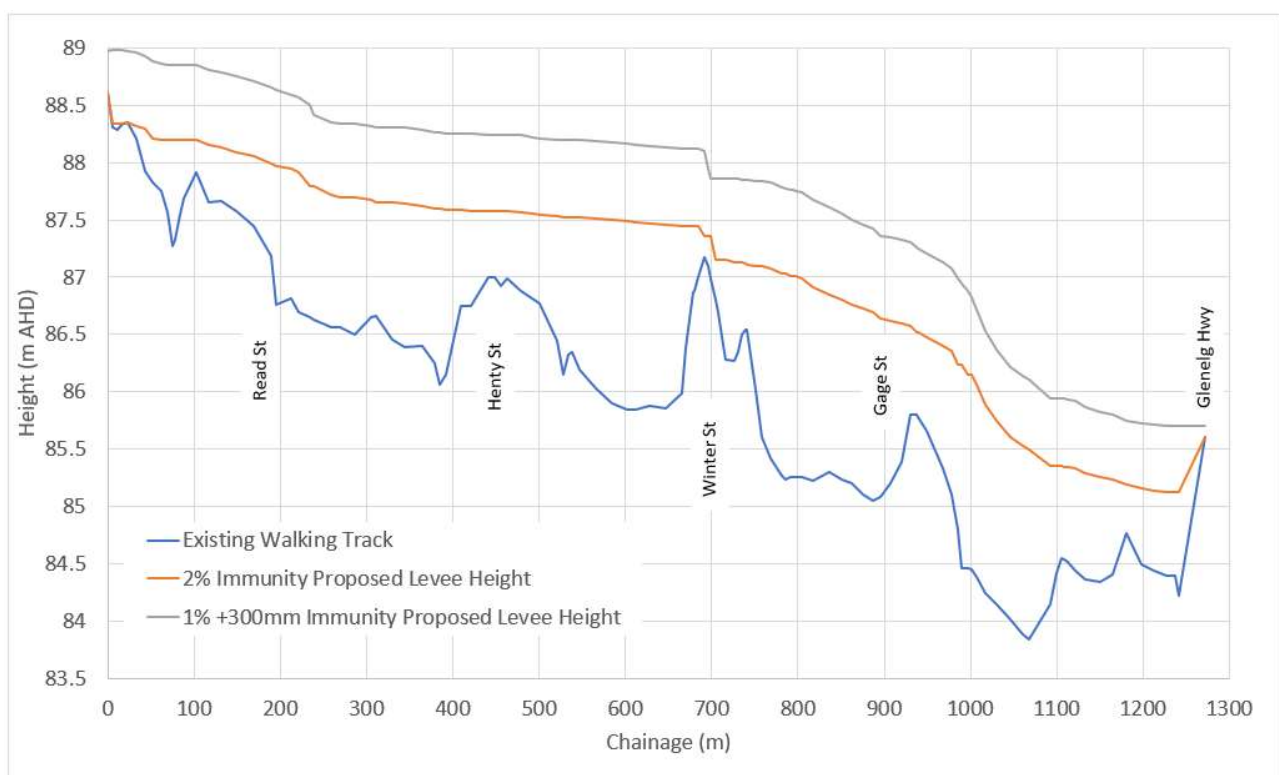
Figure 6-1 Bryan Creek Walking Track Levee Long-section

This option was identified as having the highest potential in terms of reducing over-floor flood impacts (see Table 6-1) but the potential worsening of flood impacts in the Coleraine football ground area is an important consideration. From a Cost versus Benefit perspective it was assessed as potentially warranting further consideration once intangible costs/benefits are considered (see below).

The flood damages and benefit-cost assessment have not been undertaken for a 1% AEP immunity levee, should further investigation be undertaken by Council the ultimate design level of the levee could be optimising between desired protection, the benefit-cost, visual impact and amenity of the levee.

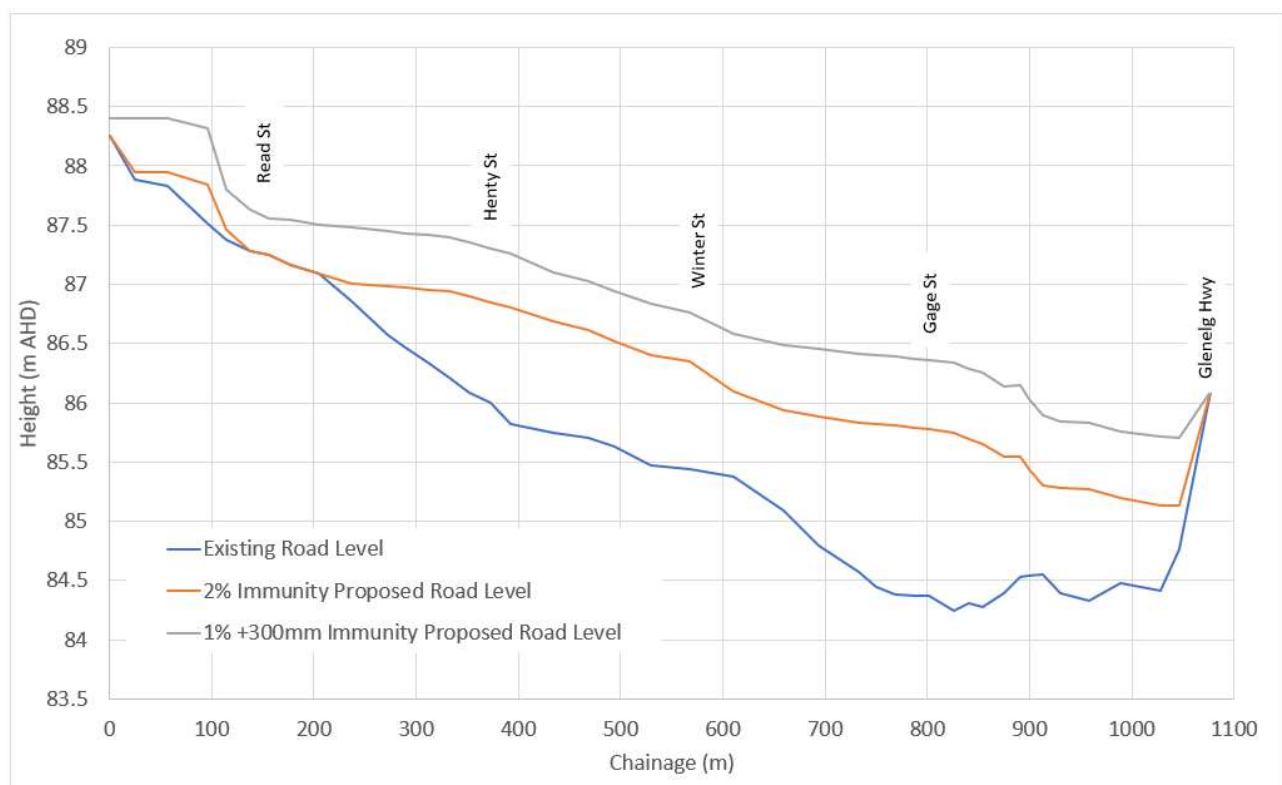
Figure 6-2 Turnbull St Raising Levee Long-section

This option was assessed as probably not warranting further consideration in isolation, even when intangible costs/benefits are considered (see Section 6.3). However it may be considered further as part of an investigation of alignments should Option 1 be further investigated.

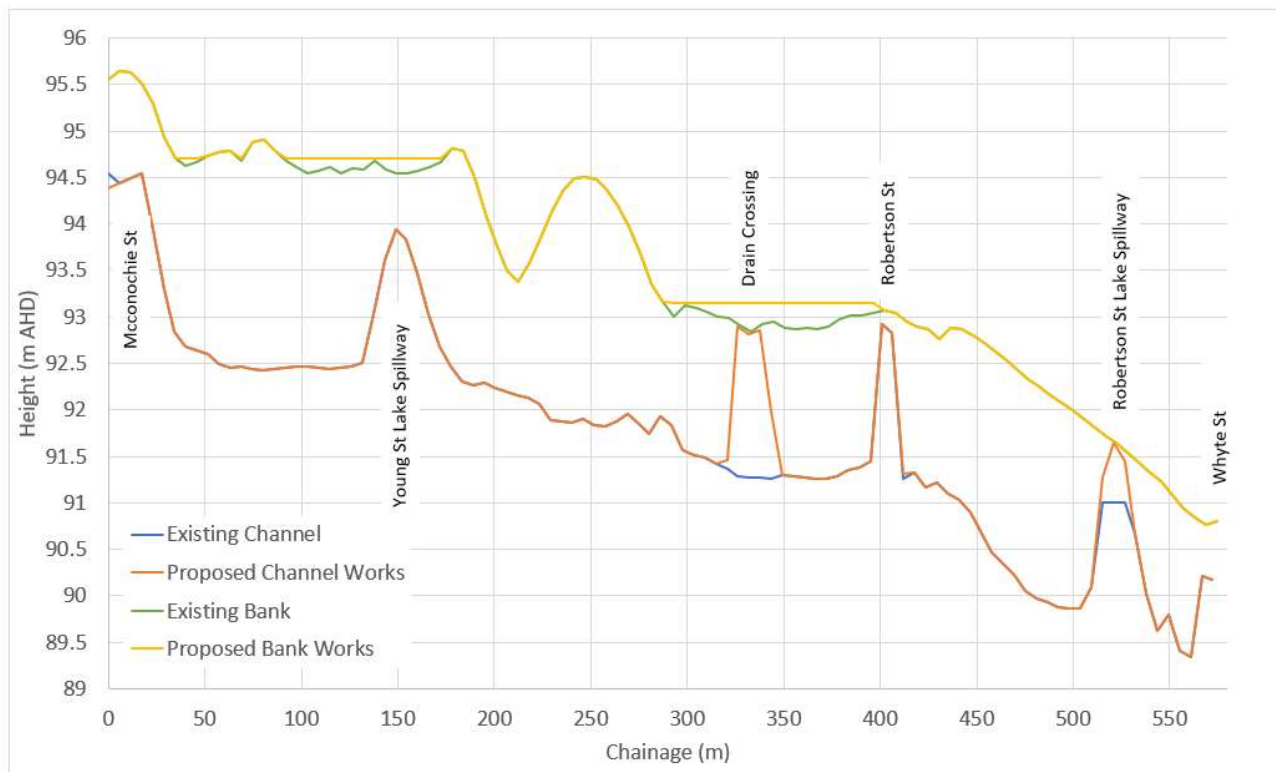
Figure 6-3 Young St and Robinson St Drain Proposed Works

This option was assessed as warranting further consideration with a good cost versus benefit ratio (see below). It would be recommended that this be investigated further in the context of other local stormwater issues that were not assessed as part of this study.

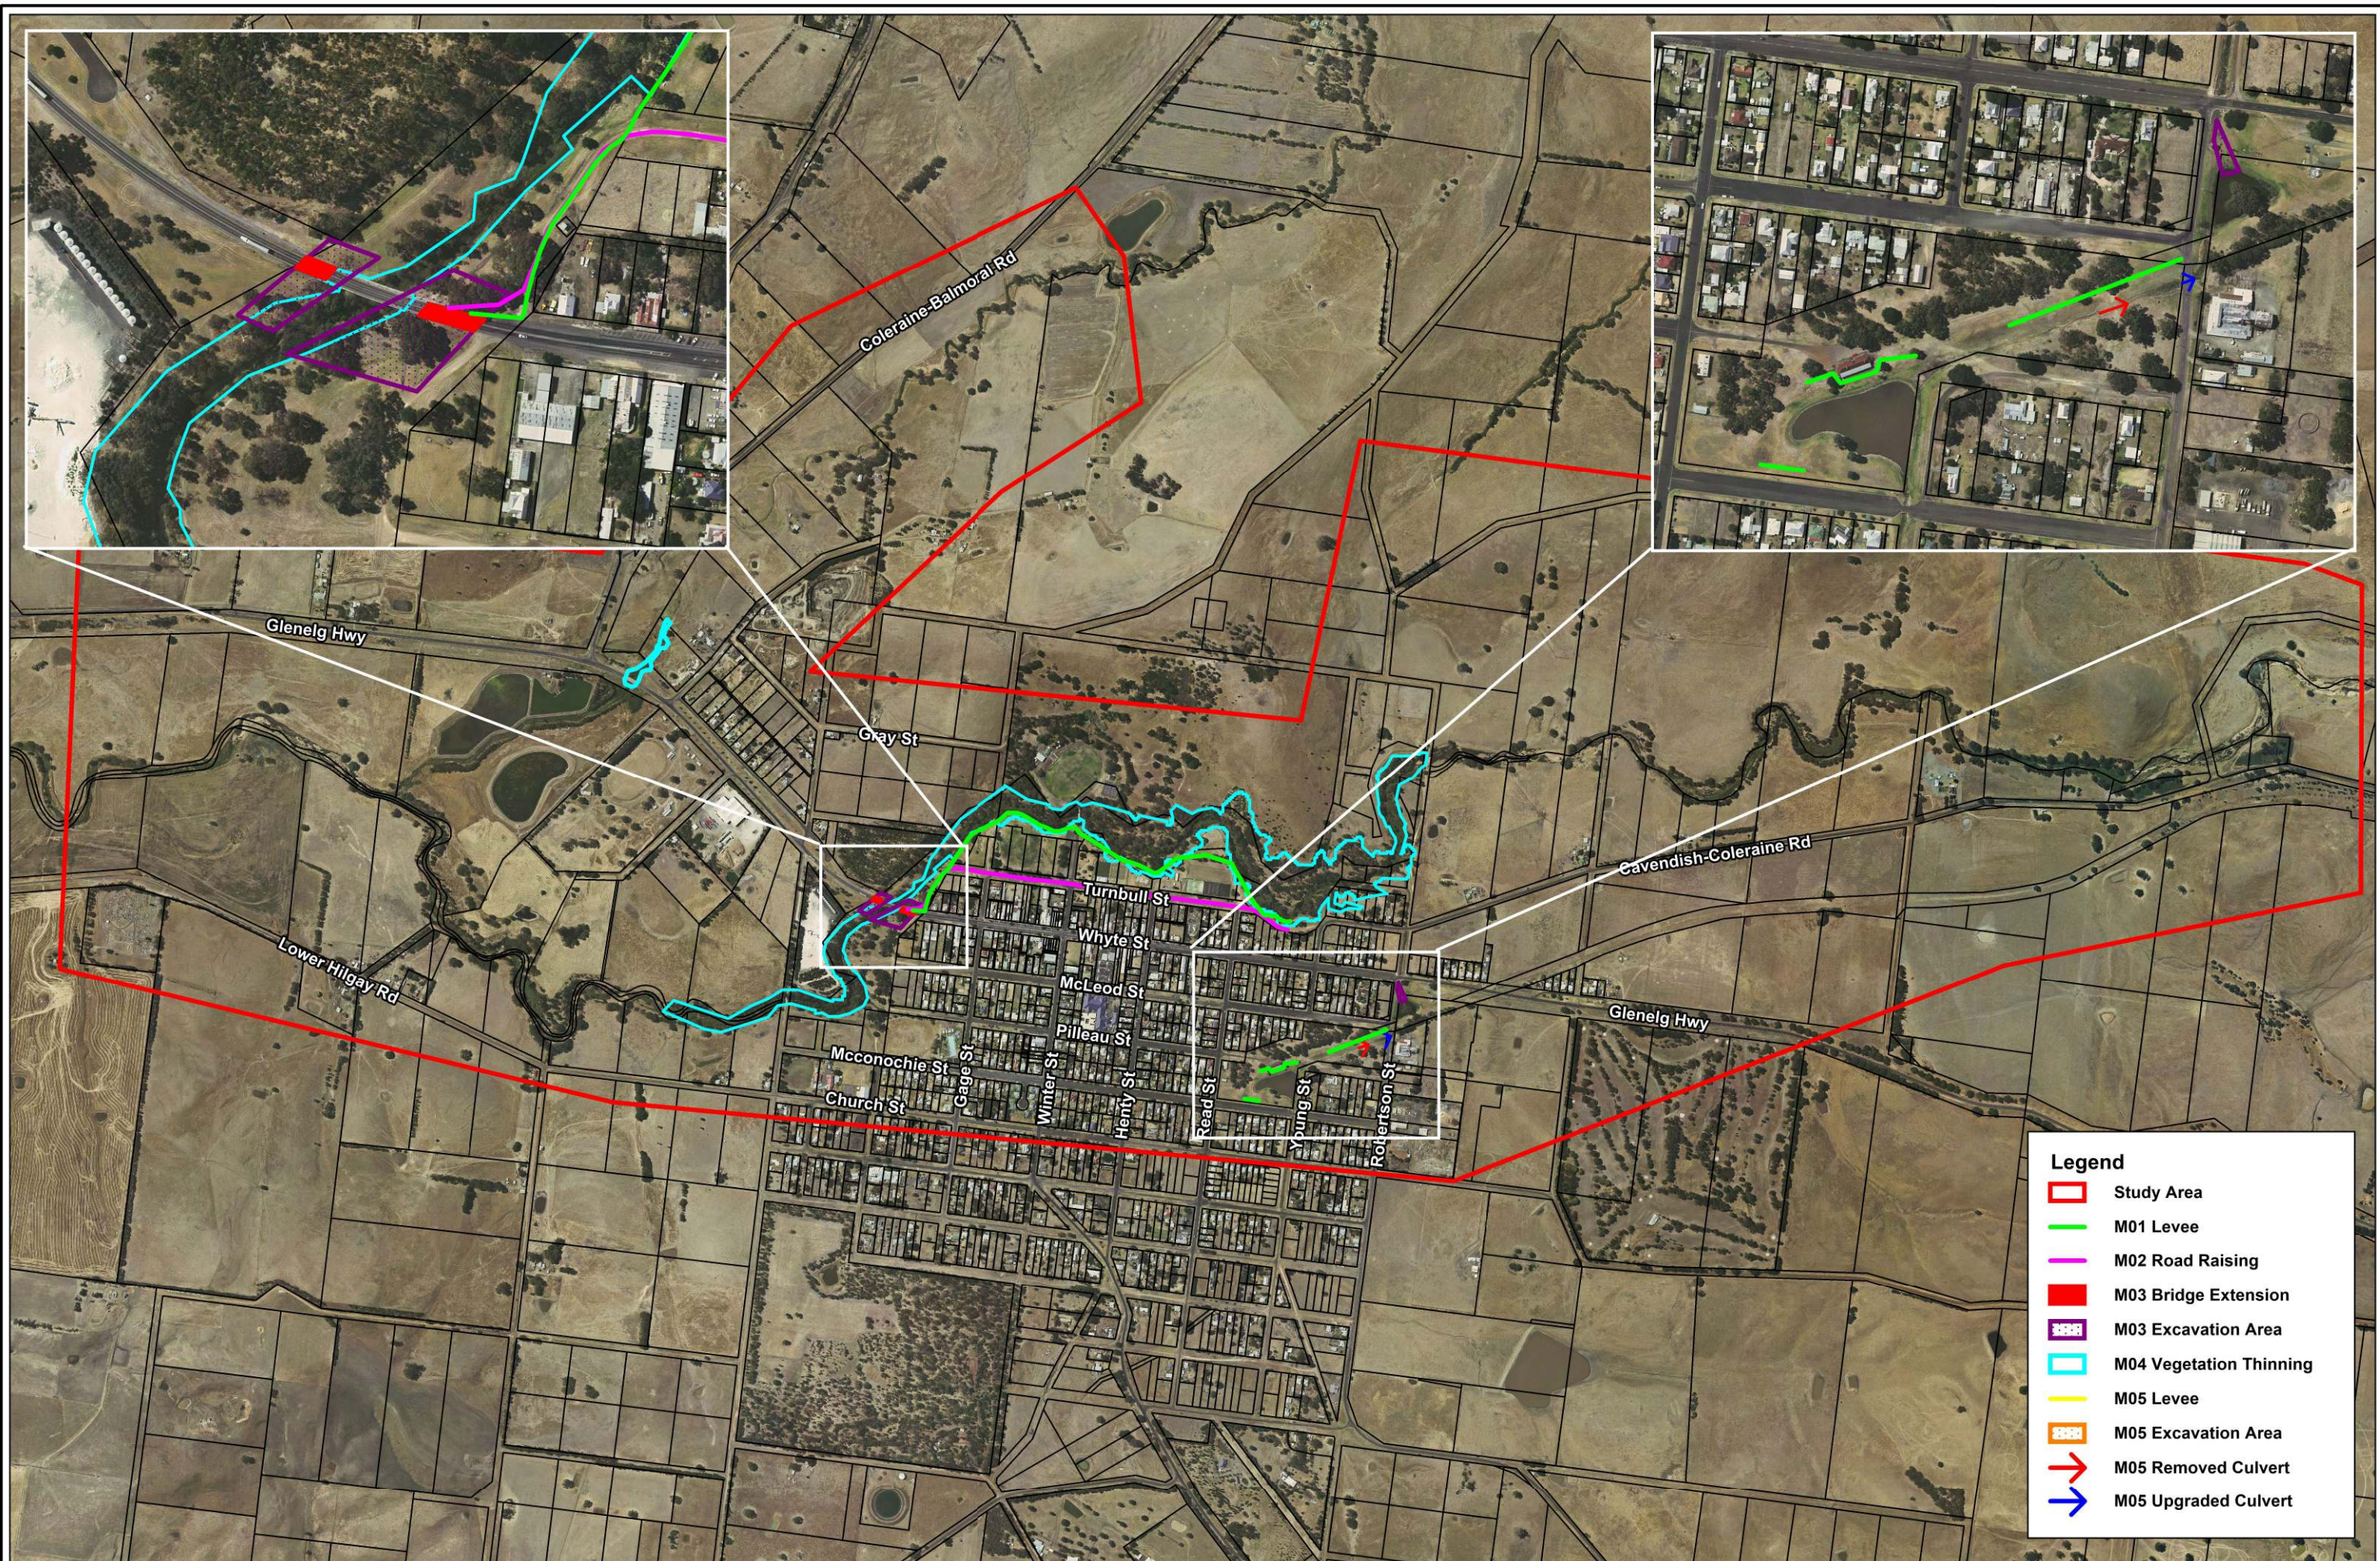
- Legend**
- Study Area
 - M01 Levee
 - M02 Road Raising
 - M03 Bridge Extension
 - M03 Excavation Area
 - M04 Vegetation Thinning
 - M05 Levee
 - M05 Excavation Area
 - ➔ M05 Removed Culvert
 - ➔ M05 Upgraded Culvert

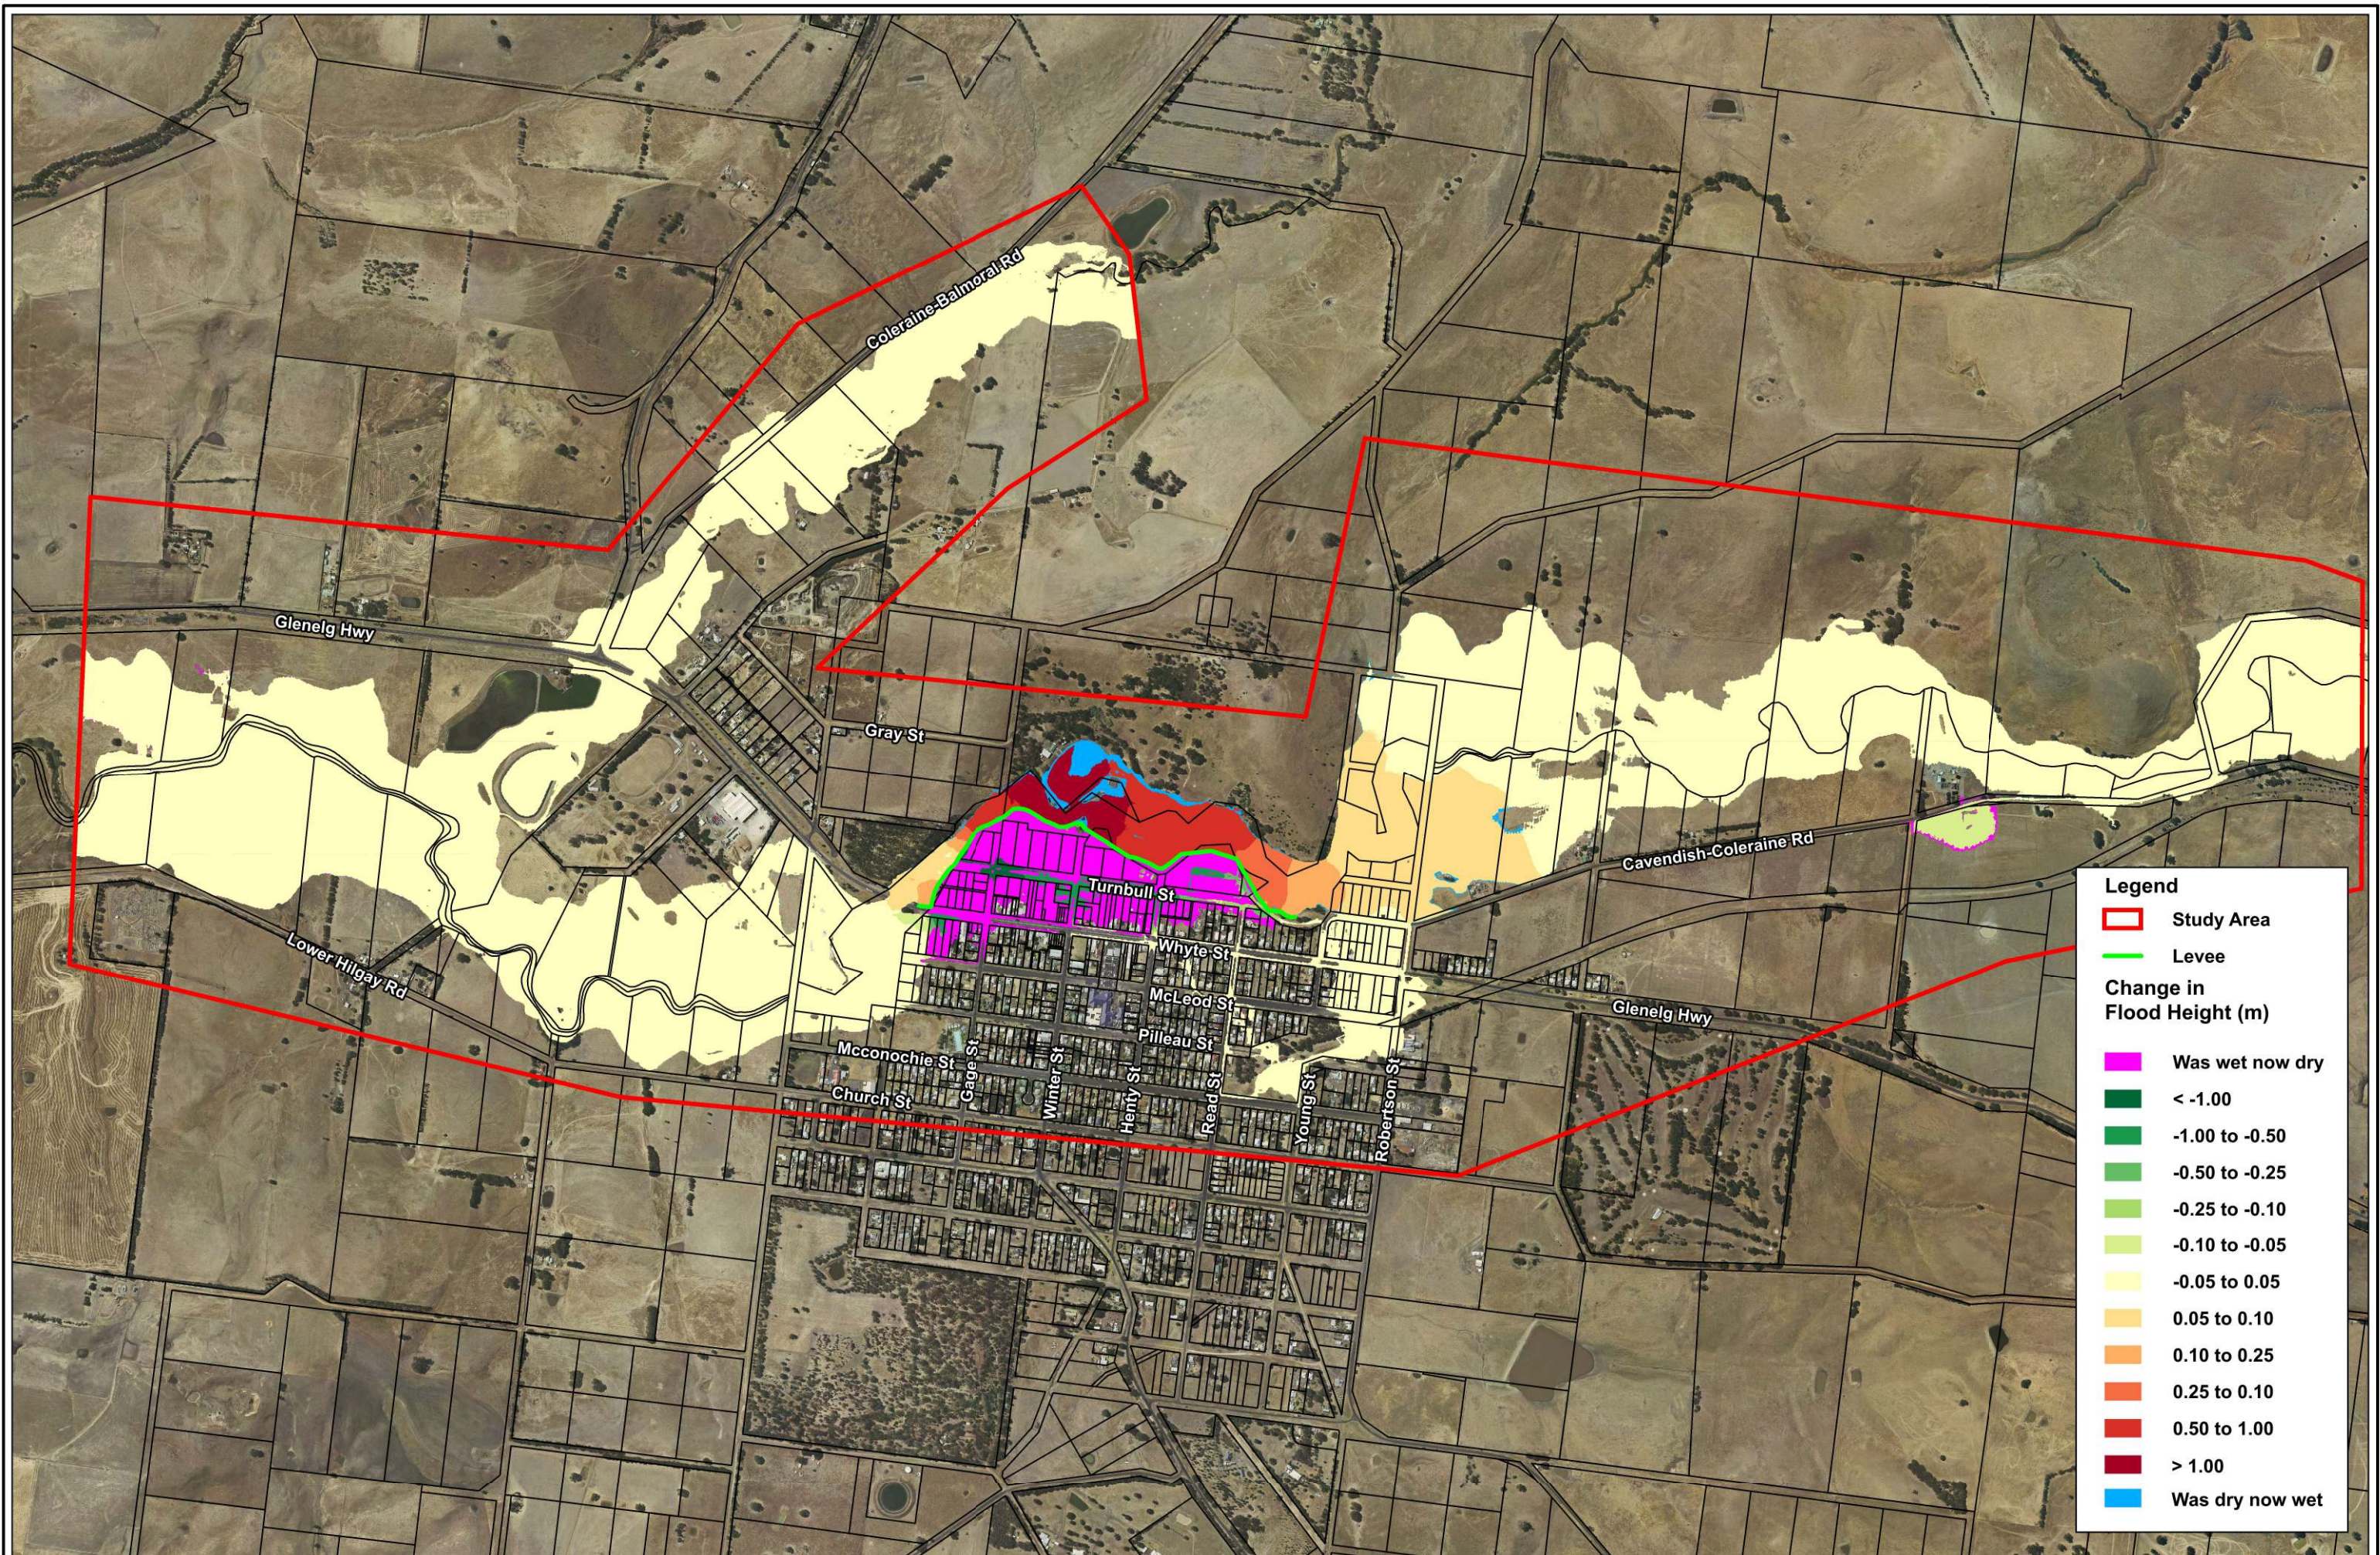
Figure:
6-5

Filepath: S:\Projects\M00136.DR.ColeraineFS\GIS\Drawings\R.M00136.008.02_FinalReport\Fig6-5_Dif_M01-E01_50y_025_hmax.WOR

The feedback from the community was discussed by the Southern Grampians Shire and Glenelg Hopkins CMA following the meeting. From the feedback on preferences received, and what was practical within the scope of the study to model, five mitigation options were agreed to be investigated in detail using the hydraulic model. The five options modelled and assessed are detailed below and presented in Figure 6-4. A summary of the estimated effectiveness of each scenario in the context of reduction in over-floor flooding is presented in Table 6-1. Figure 6-5 through Figure 6-9 present the change in peak flood levels under a 2% AEP flood event for each of the five mitigation options assessed. The 2% AEP flood event is broadly similar to the September 2016 flood event. In these figures the colour ranges signify the change in flood levels as shown in the legend. The lemon colour represents a ‘no change’ tolerance of 0.05 metres, with greens indicating reductions in flood levels, and the oranges representing increases in flood levels. The pink shaded area indicates areas that were wet and now dry, and conversely the blue shaded areas indicate where area that would be dry would be wet.
