# VOLCANIC TRAIL MASTERPLAN

## NOTES & OBSERVATIONS FROM SITE VISITS

Date: 21.08.2020

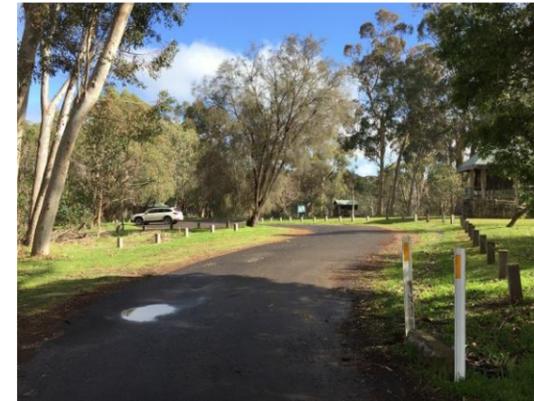
- Toilets are not fully compliant with current accessibility standards.
- There are issues with runoff from the bitumen carpark causing erosion.
- The Rotunda is currently used as a shelter for interpretations, but doesn't function well for this purpose, with steep steps up to a raised floor and a small internal floor area. Architecturally, the building doesn't relate well to the site and its presence detracts from the qualities of the natural environment.

Lower Carpark, view to rotunda & sign / shelter

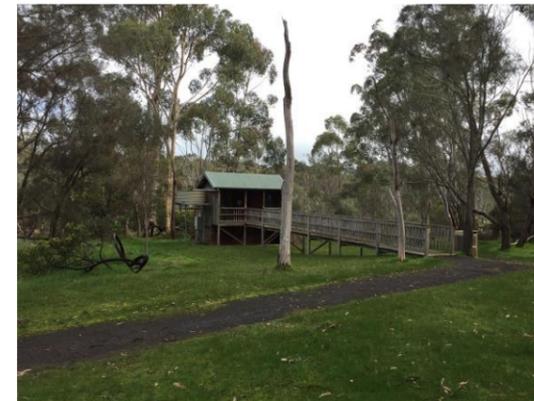
Lower Carpark, Toilets

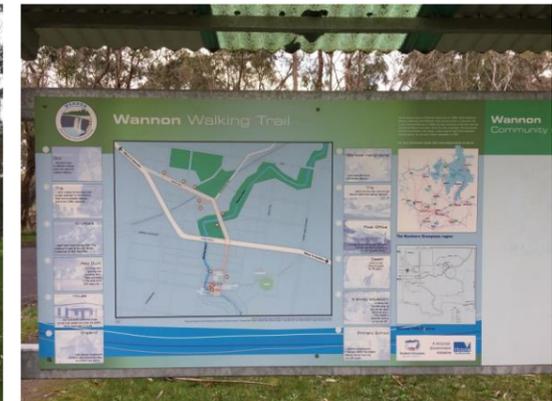
- Most infrastructure (lookout, toilets & signage) dates from 1990s and is in need of upgrade or replacement.
- The lookout floor surface (treated pine boards) has been covered in chicken wire, as it became dangerously slippery.

Lower Carpark, signboard

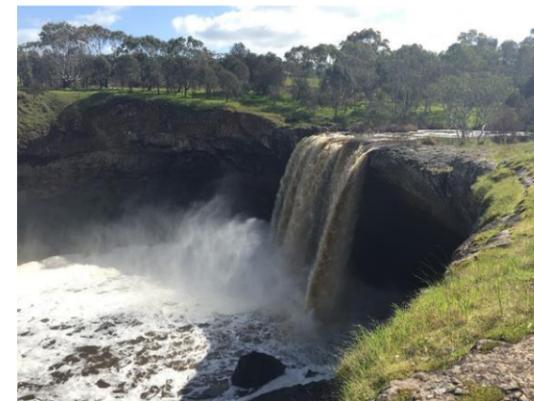
- Selective pruning / tree removal could open up better views of the falls from the carpark.

View of falls from lookout

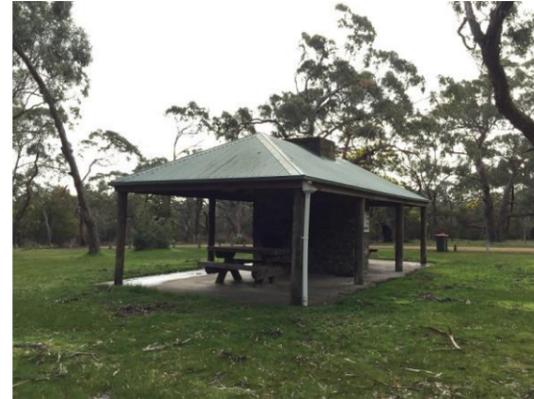
- The toilet facilities duplicate those at the lower car park. They are the same age and are also in need of upgrade.
- The picnic shelter with large built in fireplace is in good condition and works quite well, but other infrastructure appears completely unrelated to this.

Upper Carpark, picnic shelter

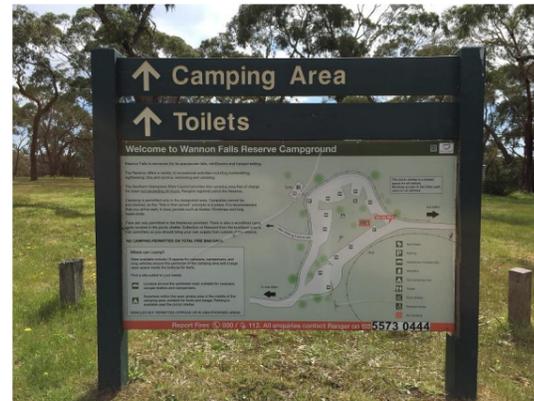
- This is an attractive bushland camp ground that is free and popular amongst backpackers and also seniors with RVs.
- The infrastructure and signage are very piecemeal and lack any overall planning or direction.

Upper Carpark, signboard

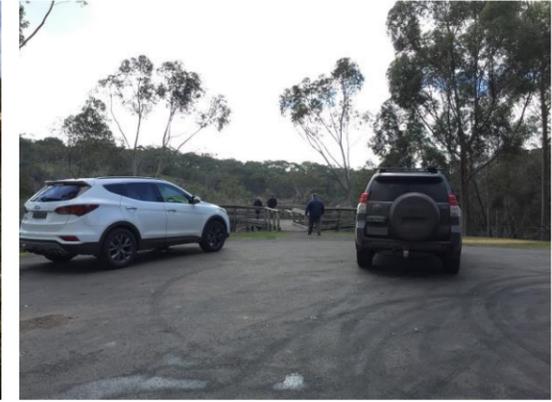
- The carpark is immediately adjacent the lookout, with no walking path or vegetation separating them. This detracts from the visitor experience, as there is very little sense of the site being revealed – it is all already visible from the carpark and the cars all remain visible while looking at the falls.

- The lookout is a similar age to that at the Wannon Falls and is also in need of upgrade. Views of the falls from the lookout are partially obscured by trees, and some selective pruning could improve view lines.

Lookout approach from main carpark

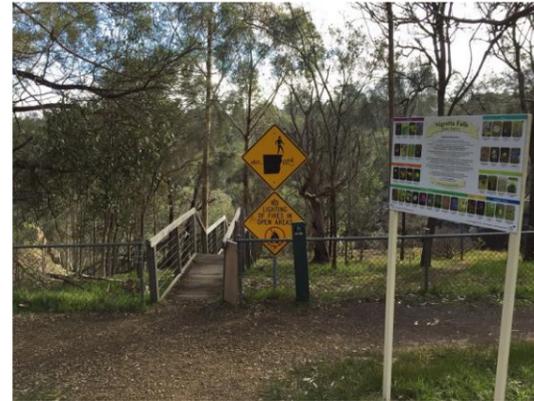
- Timber steps provide access to the base of the falls, these are starting to rot and are in need of upgrade. Compared to the more subtle style of path construction typical to national parks, the staircase structure is quite visually dominant on the slope. The access to these steps is via a poorly formed and not well marked path.

- The cyclone wire fences around the lookout and access to steps are out of place and detract from the qualities of the natural environment.
- There is a complete absence of interpretation at this site, with the exception of one sign about endemic flora that was installed by a local field naturalist group. There is also no knowledge of local indigenous history at the site.

Top of stairs, flora & warning signage

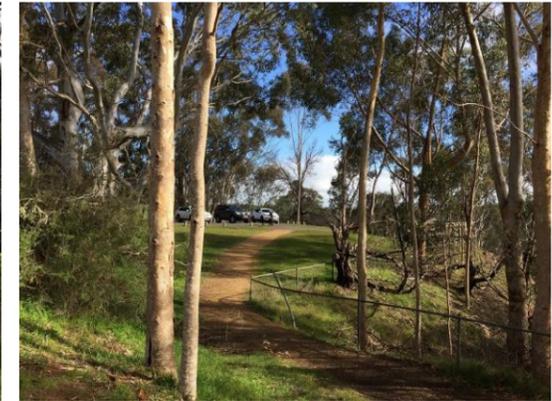
Walking path from carpark to top of stairs

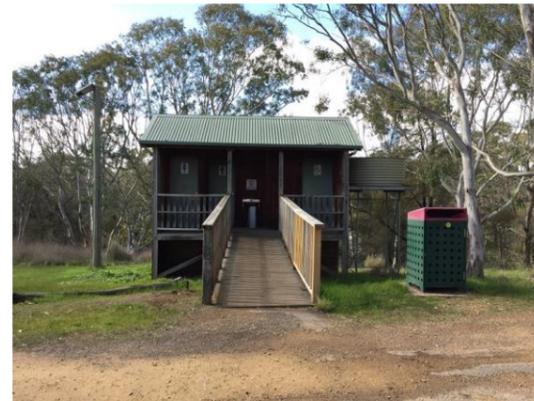
- In addition to the lookout, there are toilet facilities and a picnic shelter / tables.
- The toilets are the same age and design as those at the Wannon falls and are in good working order, but dated and in need of upgrading.

Toilets

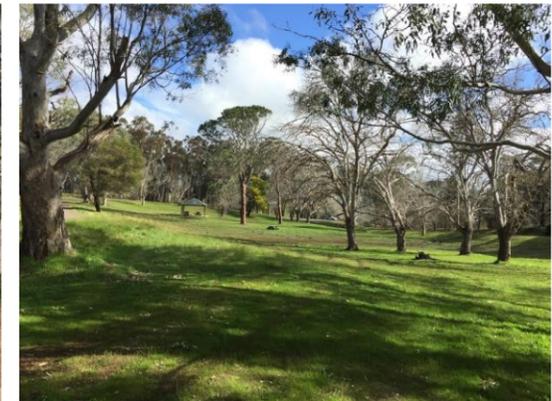
- The picnic shelter and tables are located in the grassy 'island' in the centre of the loop road. They are quite exposed, with no views of the falls and not much connection to the surrounding native landscape, being encircled by the access road and adjacent a plantation of European trees.

Picnic shelter & lawn with European trees

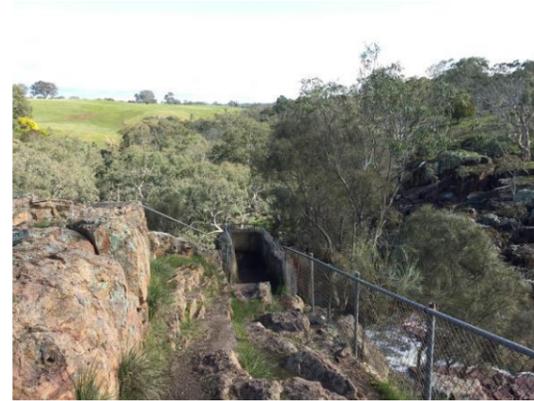
- There is a small lookout at the crest of the falls, accessed via a poorly formed and unmarked walking track. The construction of the lookout itself is very dated and not in keeping with the natural environment (such concrete poured onto natural rock surfaces, cyclone wire fencing).

Lookout at crest of falls

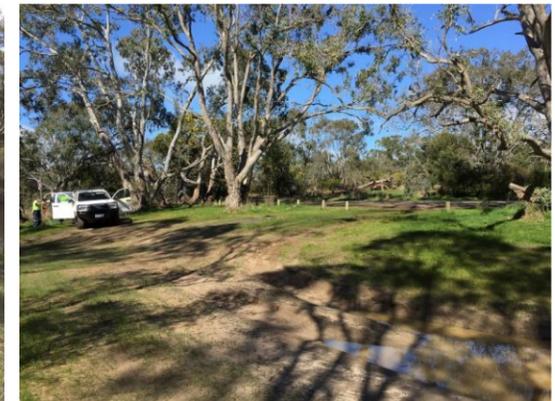
- There is a sealed road which provides access to the riverside area and terminates in a small carpark. Unfortunately, locals regularly drive off this track, causing significant erosion and degradation of the river bank.

Informal vehicle tracks causing erosion

- Other than this designated point, vehicles need to be prevented from driving down to the river edge.
- Walking trail access to a small jetty for fishing and canoe launching could be provided, and the river banks repaired and revegetated.

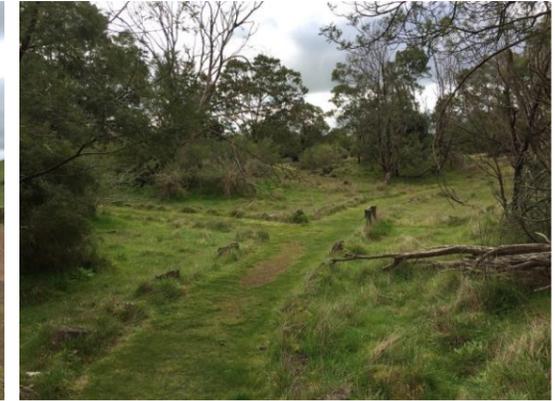
- There are a number of walking paths that consist of grassy tracks with stone edging. While they are fairly informal, this natural quality is quite attractive in the landscape and provides a contrast to the more developed sites. With some improvements to wayfinding, and maintenance of stone edges, this would be enough to direct visitors.

Typical path, grass with stone edging

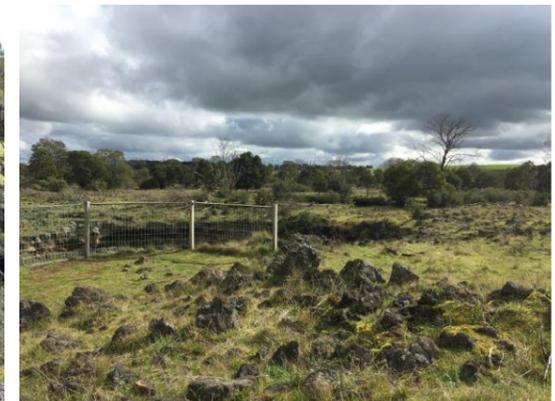
- The caves are circular formations that are open from above and formal 'lookouts' have been located at the edge of many caves, marked with a wire fence about 1.4m high. These are not particularly successful – the fences are too high and singular viewing point they provide doesn't match the nature of the formations themselves. It is clear from the informal paths around the area that visitors have a desire to circumnavigate the cave openings in order to look down into them from multiple viewpoints.

Typical cave lookout point (Bridge Cave)

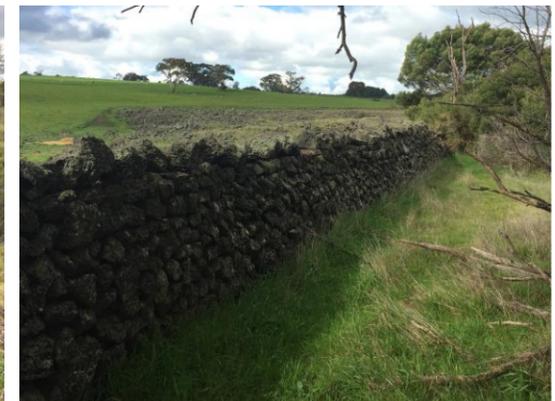
- There is very limited phone coverage, which prevents visitors accessing digital information while at the site.
- A side path takes visitors to the site of an historic dry rock wall, adjoining a farm on the northern boundary of the park. It is a good example of this type of structure and provides an opportunity to discuss Colonial history, however the current interpretive sign is almost illegible and in need of replacement.

Dry stone wall

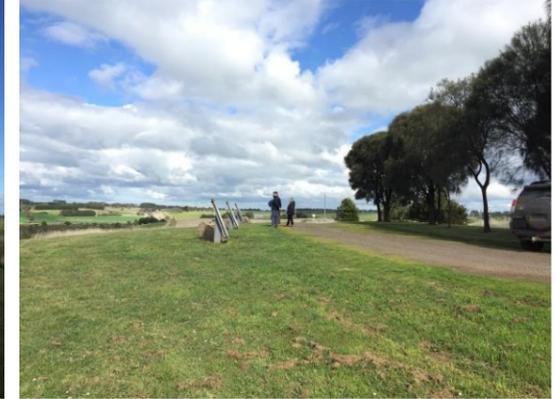
- The views down the valley are quite spectacular and provide a clear line of sight to the source of the lava flow, Mt Napier.
- Facilities include a small vehicle pullout and a series of interpretive signs, with a plantation of Allocasurinas providing a buffer to the main road.
- The current facilities are functionally adequate; however they are in need of upgrade with the road heavily potholed and signage not weathering well.

Roadside pullout and signage

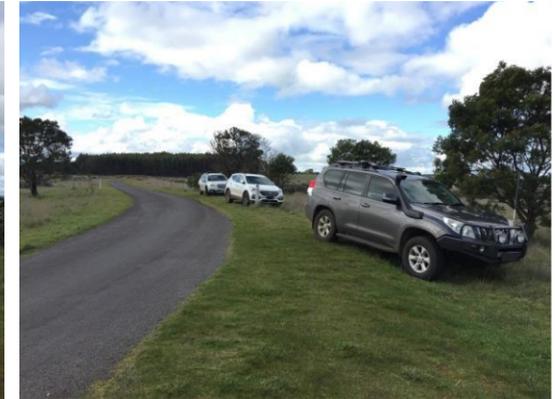
- There is little maintenance currently undertaken and the site needs to have weeds removed.
- The site is located on a bend in Old Crusher Road and because there is no carparking, vehicles simply pull onto the verge. Ideally a small car park and a dropoff / turnaround area for coaches would be provided within the road reserve. Warning signage is also needed on the approach in both directions.

Current parking on roadside reserve

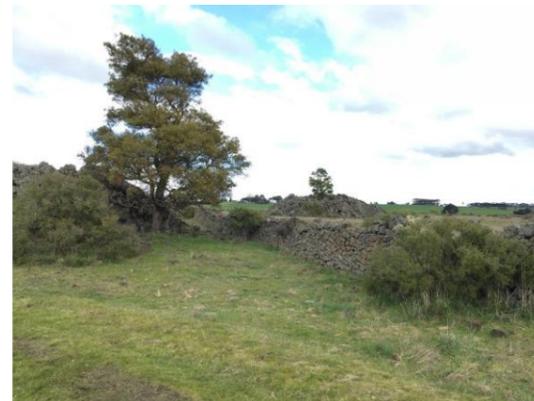
- There is a section of dry stone wall on the boundary between the Tumuli site and adjoining farmland to the west.
- The tumuli site is managed by DELWP and SGSC are responsible for the road reserve.

Dry stone wall on boundary with farmland

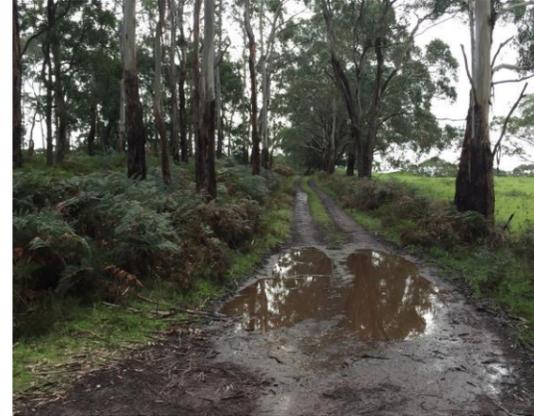
- The main access into Mt Napier State Park is on Menzels Rd, which is accessed via Murroa Lane and the Port Fairy Rd. The dirt access road is currently in poor condition and is accessible to 4WD vehicles only.
- As a state park, it has less restrictions on use than a National Park site, allowing visitors to bring dogs or horses into the park. It is also popular amongst trail bike riders and has potential to be a good site for mountain bikes also.
- The site is well-suited to visitors who and are willing to stay for a longer time and are looking for a more adventurous outdoor experience.
- There is limited mobile phone coverage.
- As with all the other Volcanic Trail sites, there is no knowledge of the traditional owner's history or connections to country.

Menzies Pit Rd access track

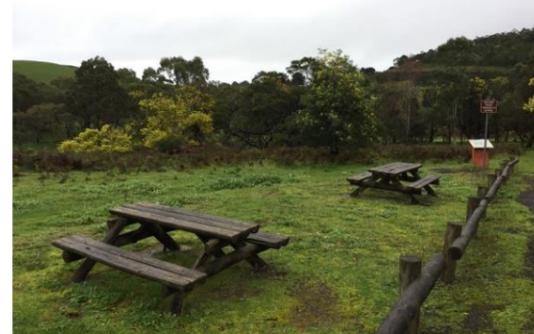
- There is no signage to direct visitors to this carpark, and many would drive past it without realizing it is there.
- There is a single interpretative sign, the picnic tables are in disrepair and the area is not well used.

Picnic tables & signage at Lower carpark

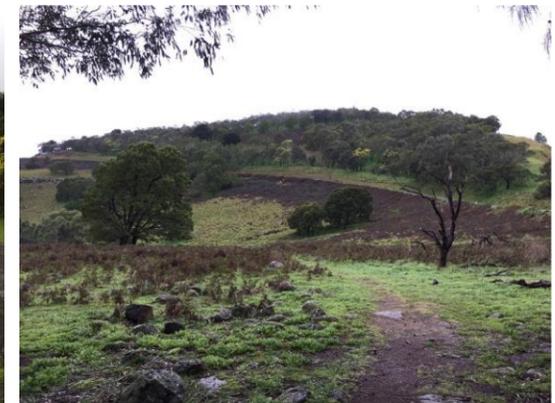
- The crater, which sits well below the summit, is quite picturesque and potentially more significant as a volcanic feature than the summit. It is accessible within about 100m of the car park, although there is no formed walking trail.

Informal path into crater

- Some locals drive their vehicles off road and into the crater. This needs to be discouraged to prevent damage.

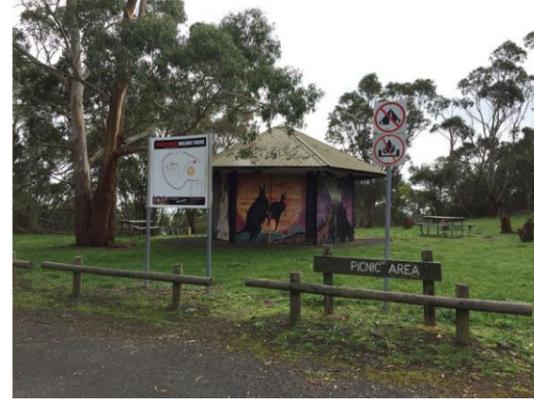
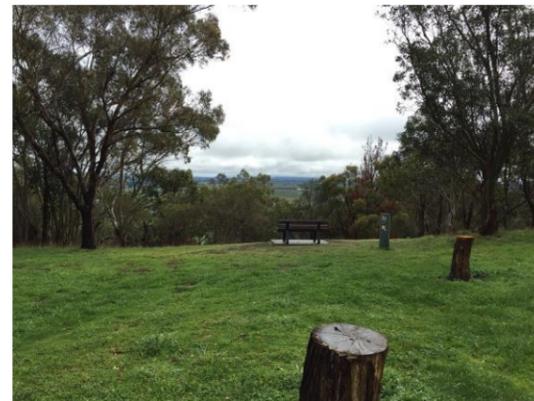
- The facilities at the picnic ground consist of a shelter with an electric BBQ and picnic table, a toilet and some bench seating. There are opportunities for attractive views to the north toward the Grampians and over Peshurst. These are partly obscured by trees and some selective pruning would open up these views.

- The facilities themselves are very aged and in need of upgrade. The location of the shelter itself dominates the view from the car park.
- There is a map provided that illustrates the loop walk and summit lookout but no other interpretations are provided at the site.

Upper Carpark / Picnic ground

Upper Carpark Picnic ground

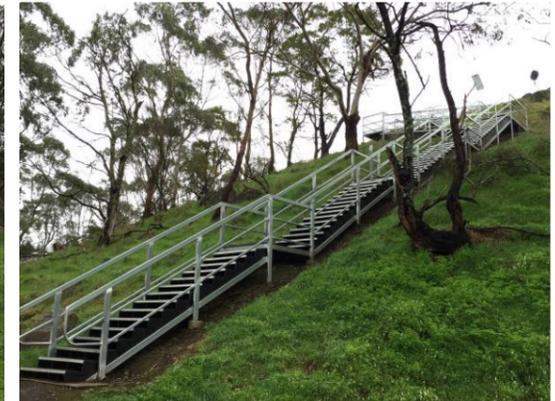
- From the small carpark, a recently installed aluminium-framed staircase provides pedestrian access to a lookout on the summit. The choice of bright aluminium means the staircase stands out against the natural landscape rather than recedes. Beside the lookout, there is also an older informal track leading to a bench seat.

Staircase to summit lookout

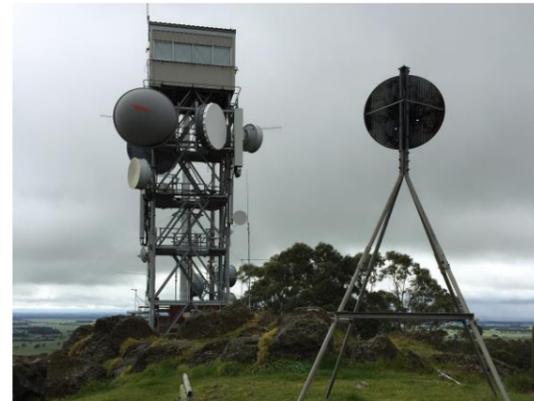
- The summit is also the site of a significant amount of telecommunications infrastructure, including towers and associated buildings, which unfortunately obstruct view lines and are dominate the site.

Telecommunications equipment on summit

- It is difficult to screen these buildings without restricting views as they are so close to the lookout, however if visitors are being directed to this site then this issue needs to be addressed, as the current state of these buildings detracts from the quality of the experience.
